Execution of camera inspections at vacuum sewerage at 4 project sites

Oceanhamnen - Helsingborg

November 29, 2024

Our reference R002-1288399-002RFL-V01-mdg-NL

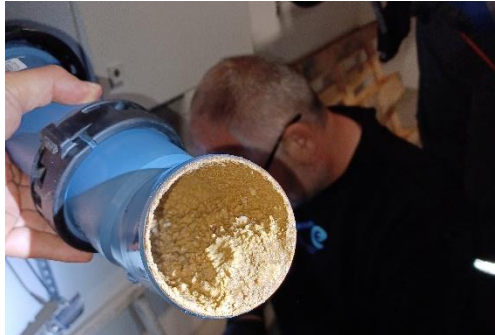
Figure 4.1 Severe deposit formation in the bend right before pipe leaves the building

In the bend from vertical to horizontal piping after inspection point 4 (via pressure meter), very severe scaling could be observed (Figure 4.1). This was the most severe scaling we observed during the inspections. After the bend, the vacuum pipe leaves the building towards the shut-off valve in the street. Here only minor deposits have formed.

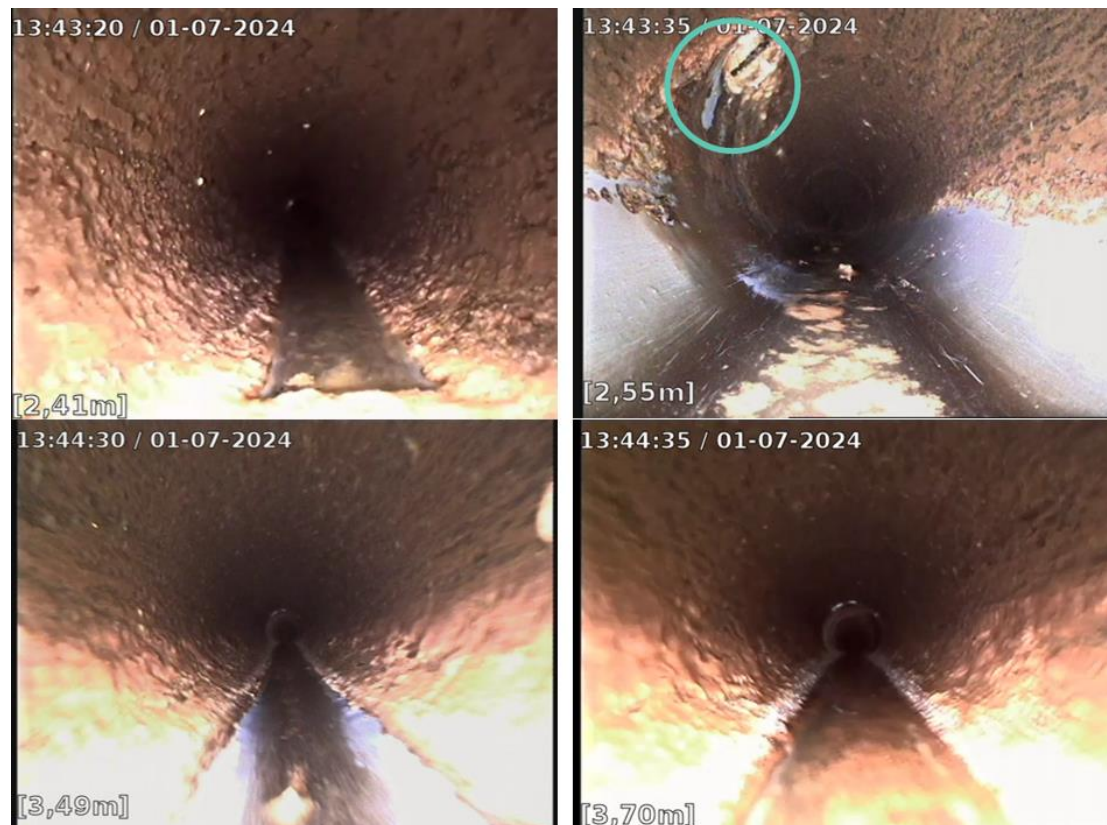
Figure 4.6 Effect of automatic descale dosing. Top left: ca. 0,1m before dosing, top right: circle shows dosing point, bottom left: ca. 0,9 m after dosing, bottom right: ca. 1,1 m after dosing

At the pipe segment between point 13 and point 14, there is an automatic descale gel dosing unit (10 ml every 8 hours). The descale gel removes/ prevents the formation of scaling at the bottom of the pipe, as can be seen in the images below. The effect is however limited, because the clean bottom is observable only from 10 cm before the dosing point to a maximum of 1,1 m after the dosing point.

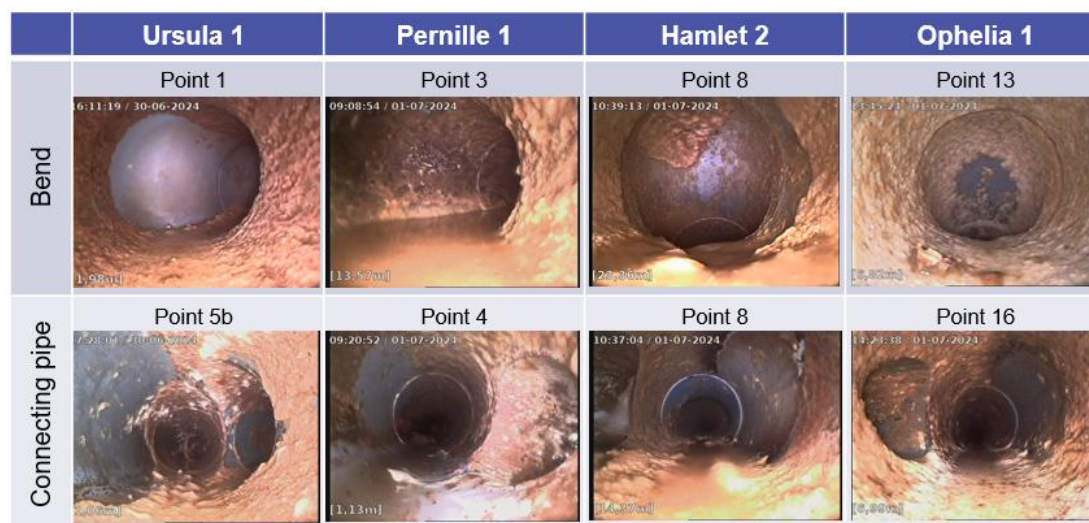
Figure 4.7 Examples of the abrasive effect of black water in bends and at pipe walls opposite connecting pipes

In all buildings we saw that most outer bends and pipe walls opposite connections are cleaner than the rest of the pipe (see Figure 4.7). This pattern was especially visible in Ursula 1 and Hamlet 2, whereas in Pernille 1 and Ophelia 1 the bends and connections were only slightly cleaner. In Hamlet 2 and Ophelia 1, the abrasive effect in bends and at connections appeared to become less further down the pipe, towards the vacuum station. Overall, there was no clear relationship between the distance in the pipe and the severity of the deposits.

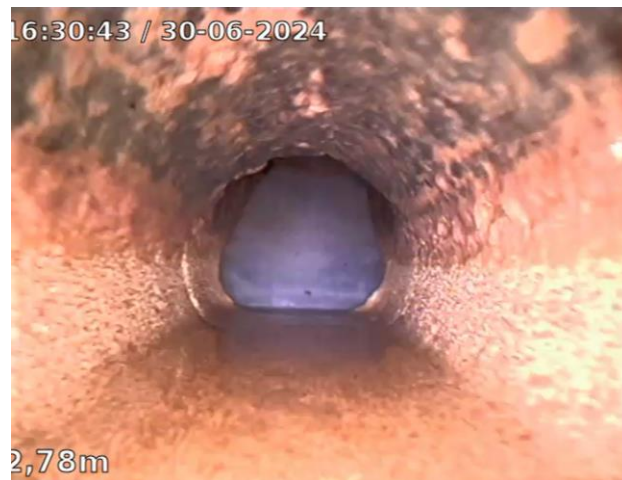
Relatively clean bend at the end

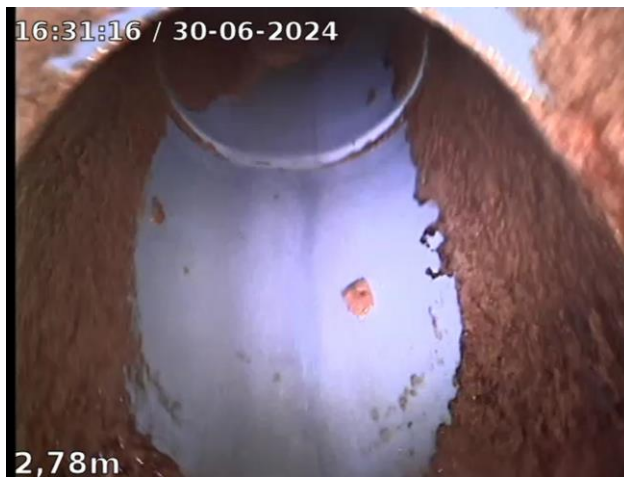
Wider pipe, shut-off valve is visible at the end of the pipe

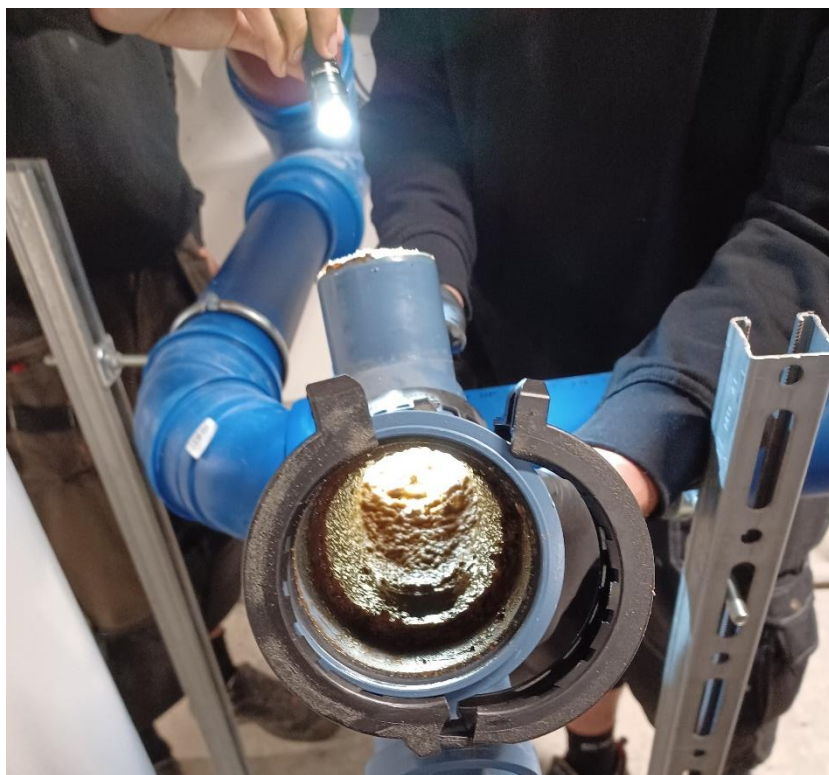
Vertical pipe towards the bend

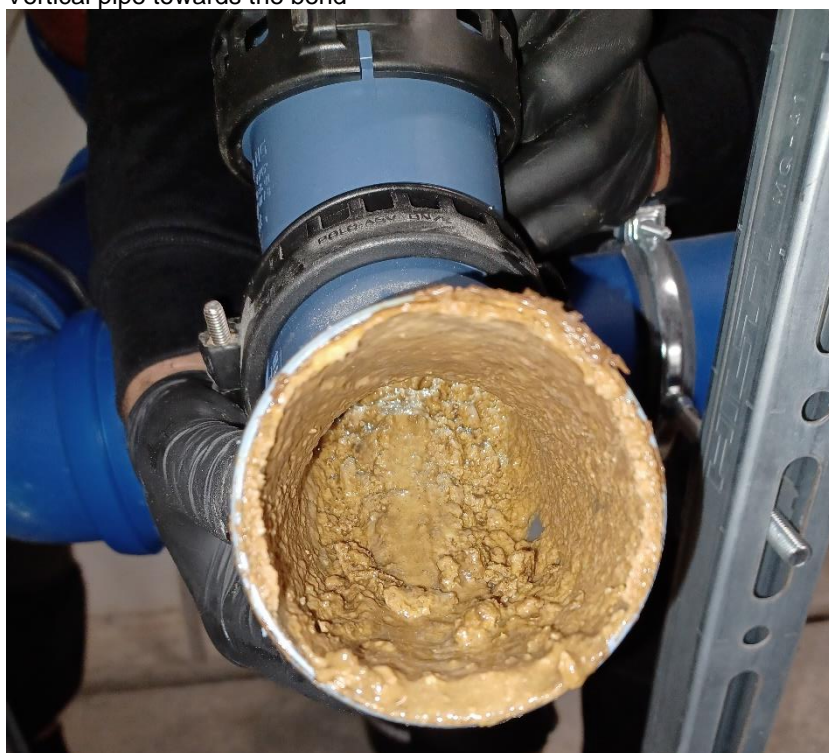
Start of the bend

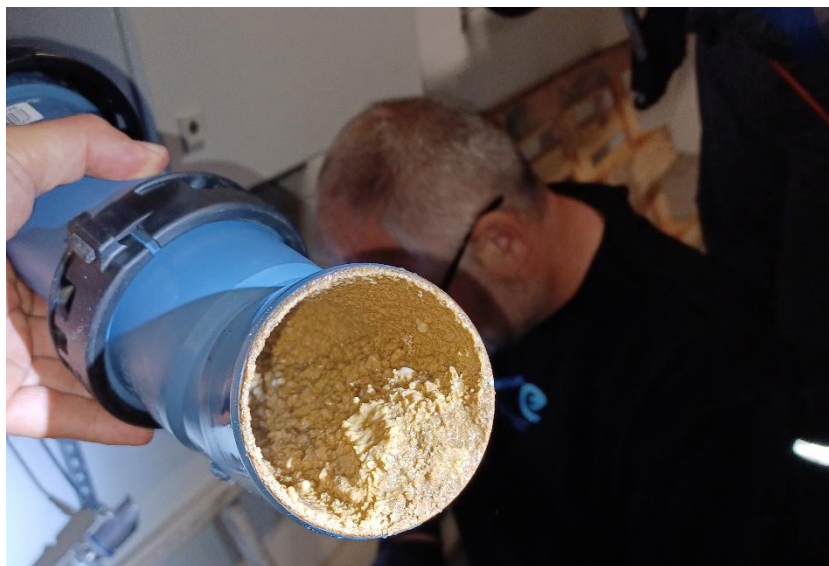
The bend was disconnected piece by piece, the bend had very severe scaling, right after the bend, the scaling decreased rapidly.

Bend

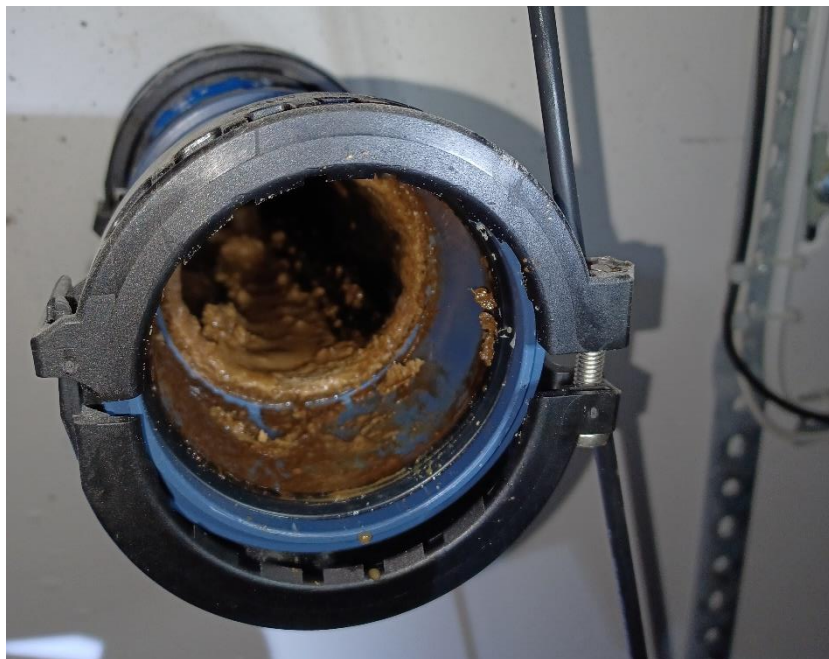
Right after the bend

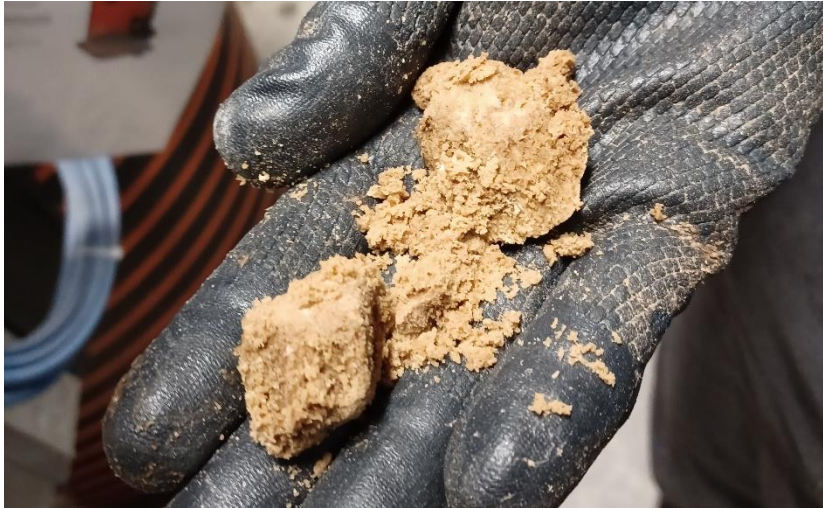
Some pieces of scaling removed from the band

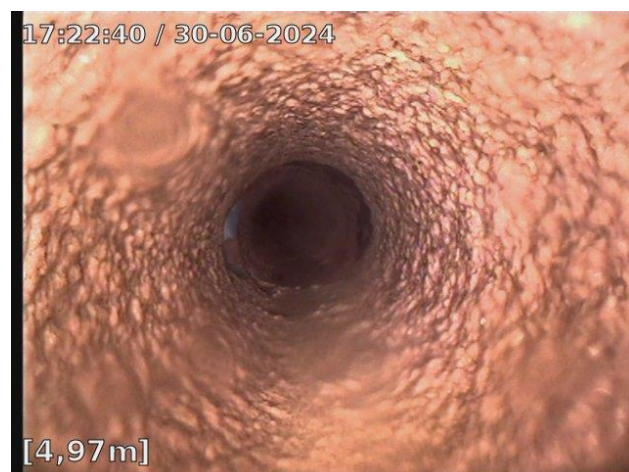
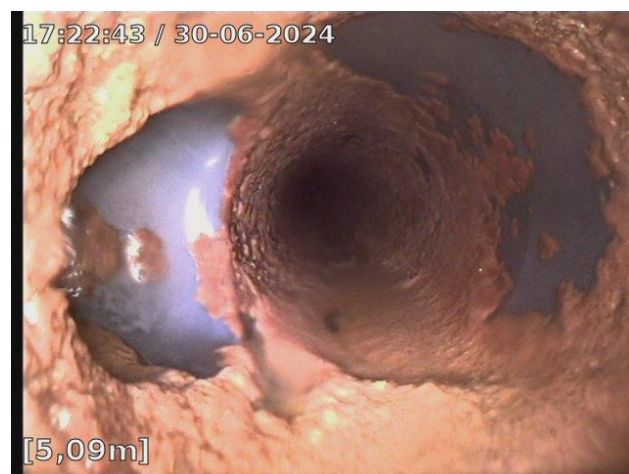
On the left the connection of another vacuum pipe is visible. The pipe wall opposite the connection is clean

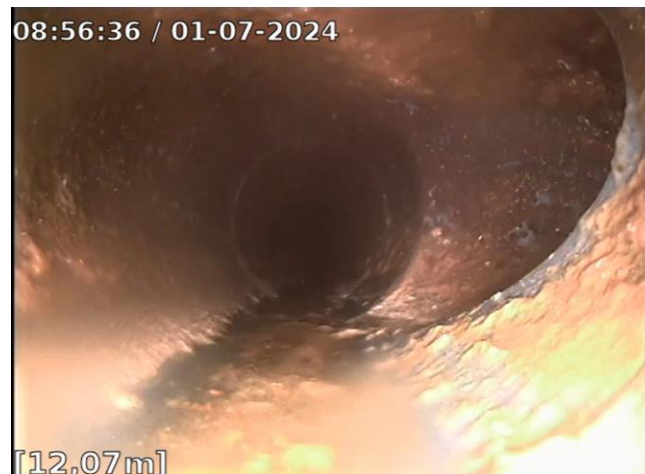
On the right, another vacuum pipe is connected

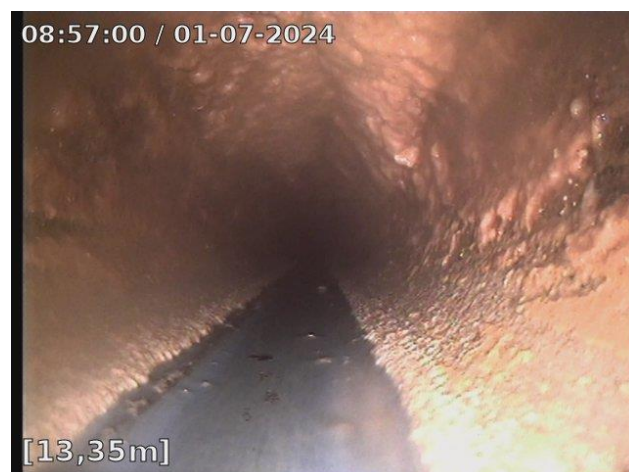
Thick layer on the ceiling, bottom is clean

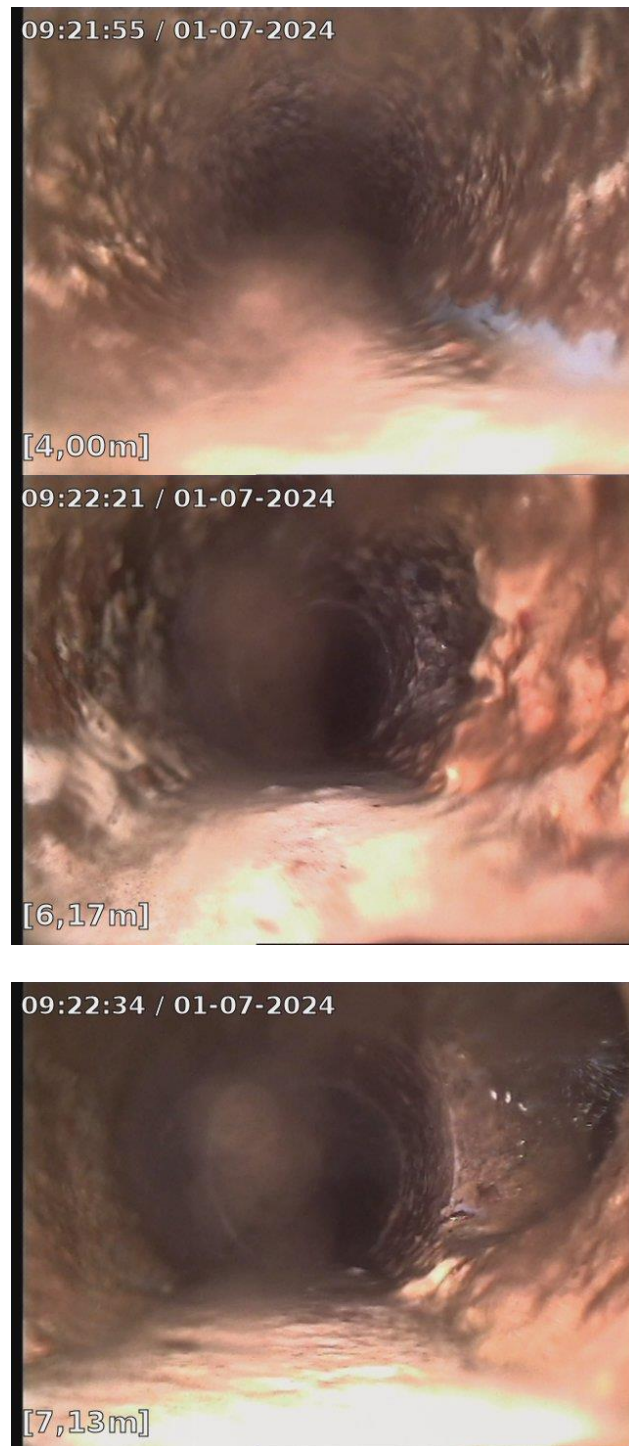
On the right the connection of another vacuum pipe is visible. The pipe wall opposite the connection is not cleaner

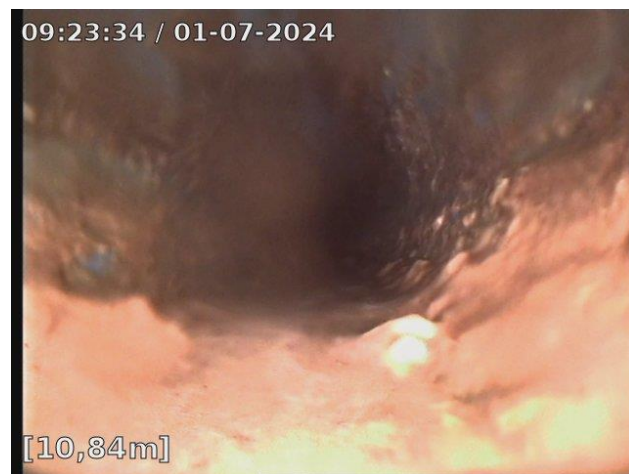
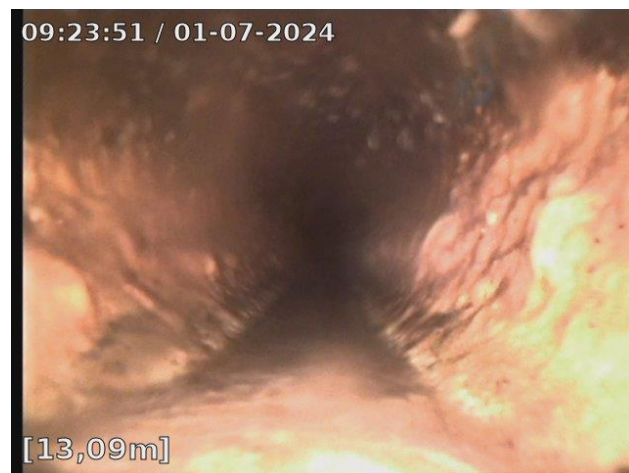
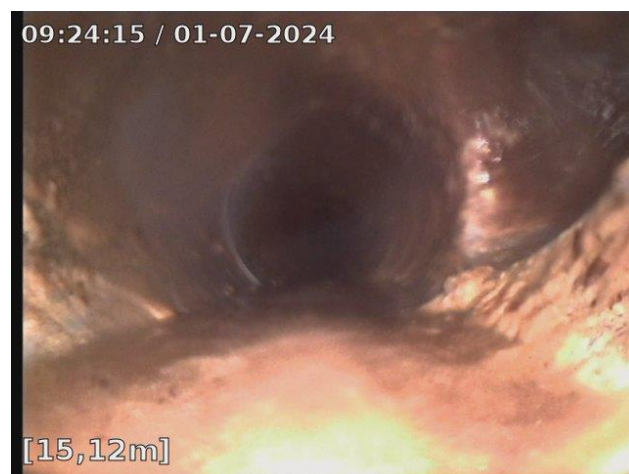
On the right the connection of another vacuum pipe is visible. The pipe wall opposite the connection is a bit cleaner

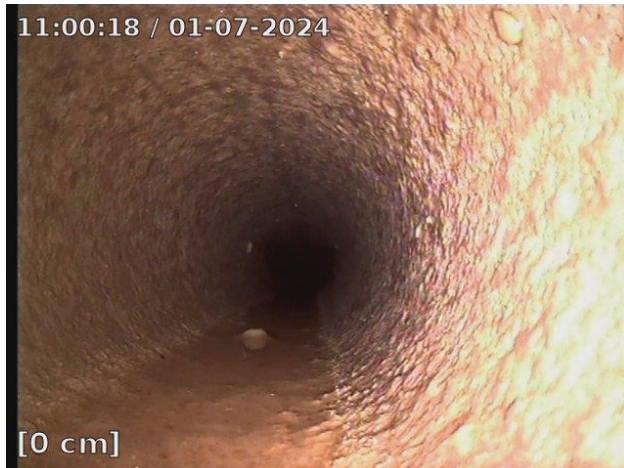
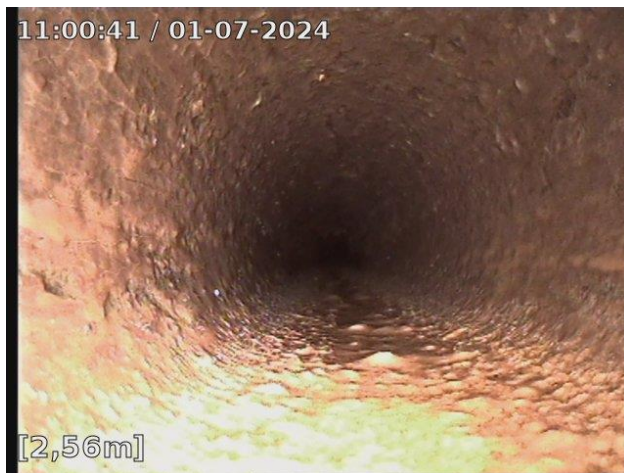
In this piping segment, the transport pocket has been replaced due to blockages.

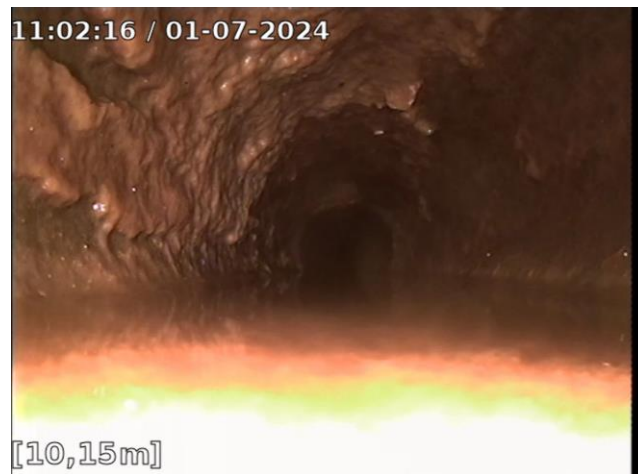
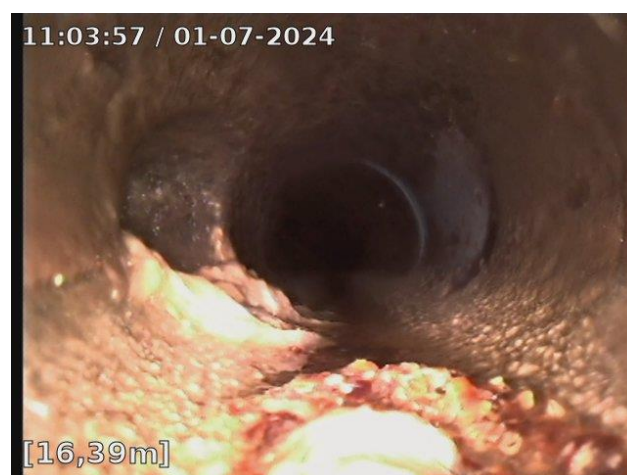
On the left, the connection of another vacuum pipe is visible. The pipe wall opposite the connection is clean

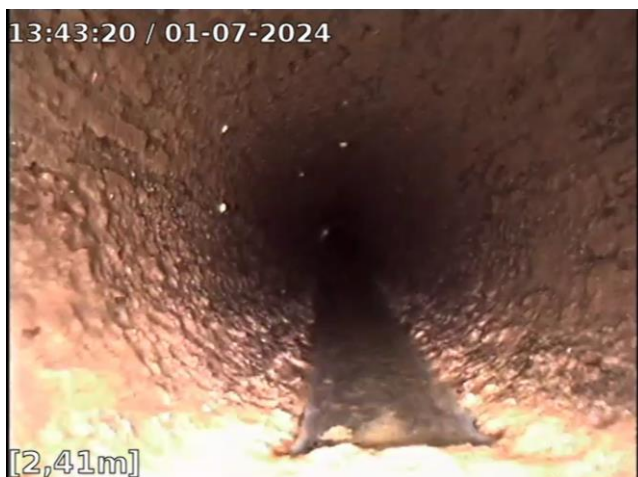
This image is taken just before the dosing point of the descaling gel. The suddenly clean bottom of the pipe is probably caused by the descaling gel.

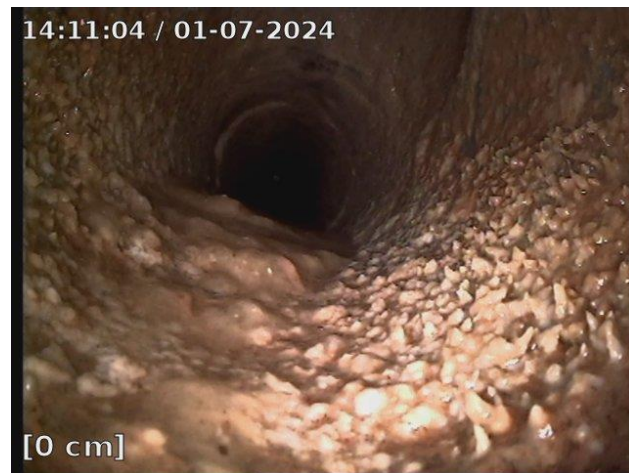
Thick layer of deposits

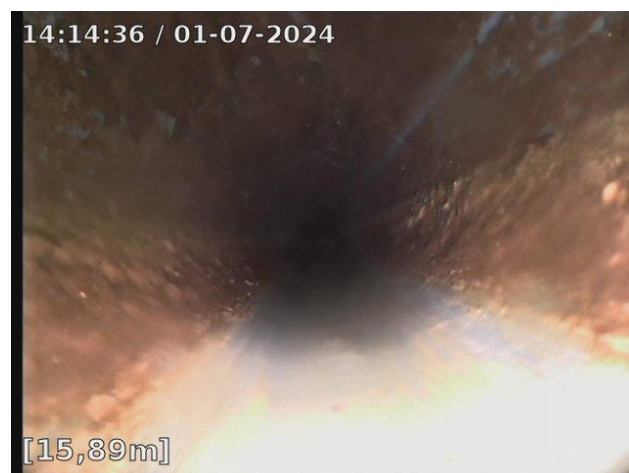
'highway effect'
