Execution of camera inspections at vacuum sewerage at 4 project sites

Oceanhamnen - Helsingborg

November 29, 2024

Our reference R002-1288399-002RFL-V01-mdg-NL

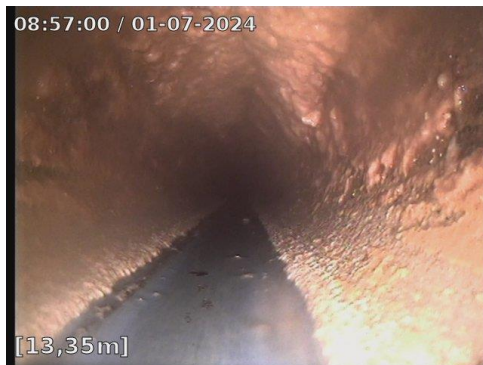
The pipe segments inspected at point 1, 3 and part of point 4 show quite severe deposits, sometimes narrowing the pipe diameter. The scaling in the pipe segment between points 2 and 1 is slightly less severe and shows a 'highway pattern' (deposits all around the pipe, except the bottom, see image below).

Figure 4.2 'Highway pattern' in the pipe segment inspected from point 2 towards point 1

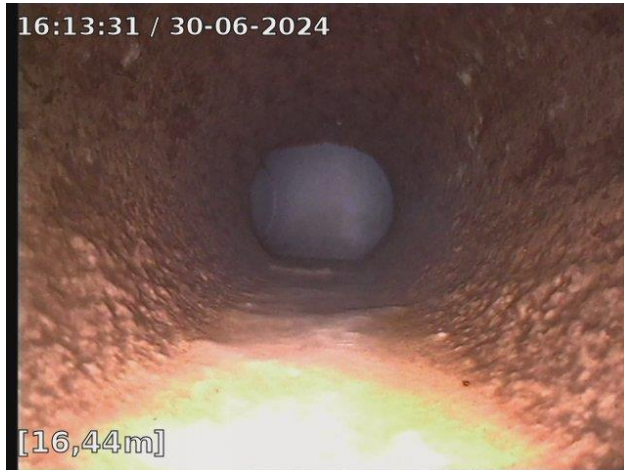
Relatively clean bend at the end

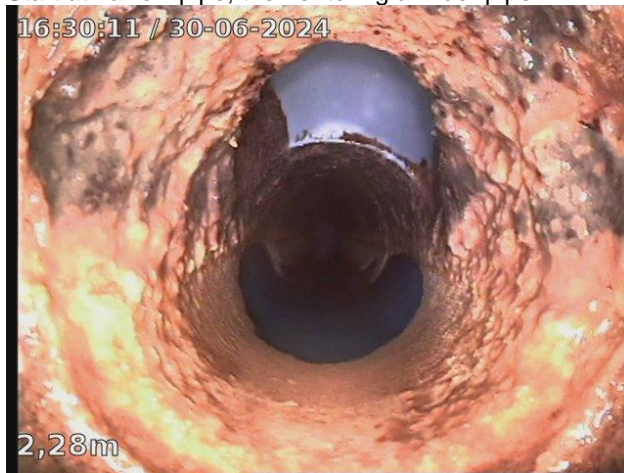
Start at narrow pipe, then entering a wider pipe

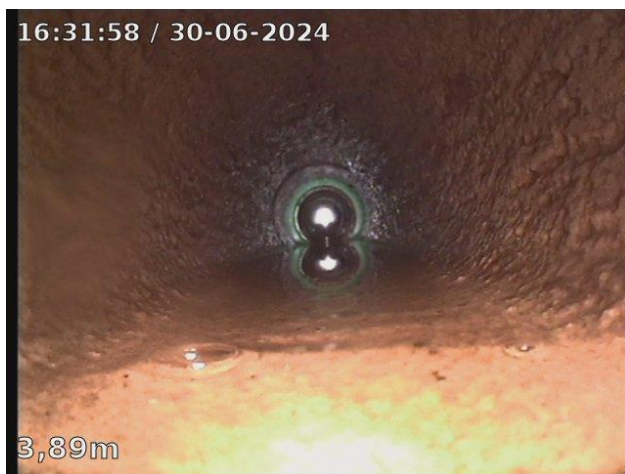
Wider pipe, shut-off valve is visible at the end of the pipe

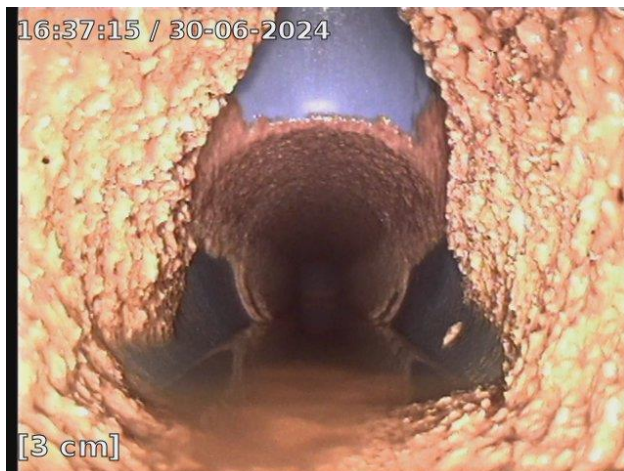
At the top the connection of another vacuum pipe is visible. The pipe wall opposite the connection is clean

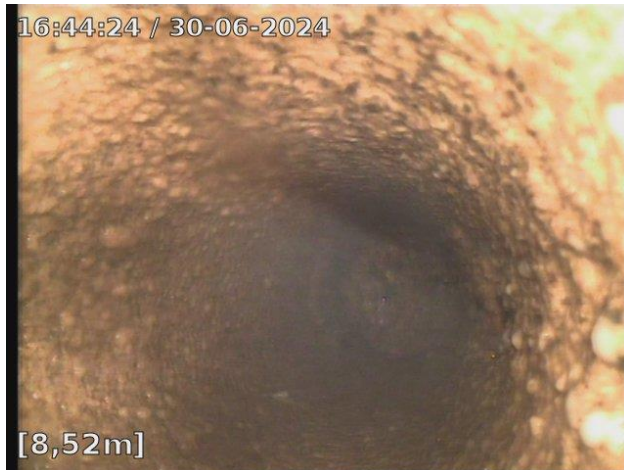
Smaller camera, right side is the bottom of the pipe

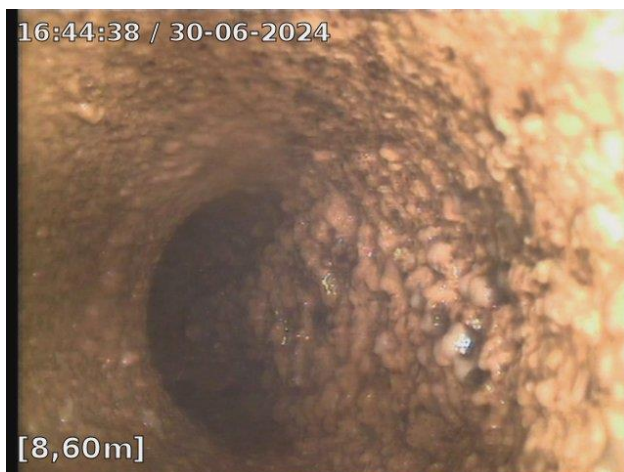
Smaller camera, right side is the bottom of the pipe

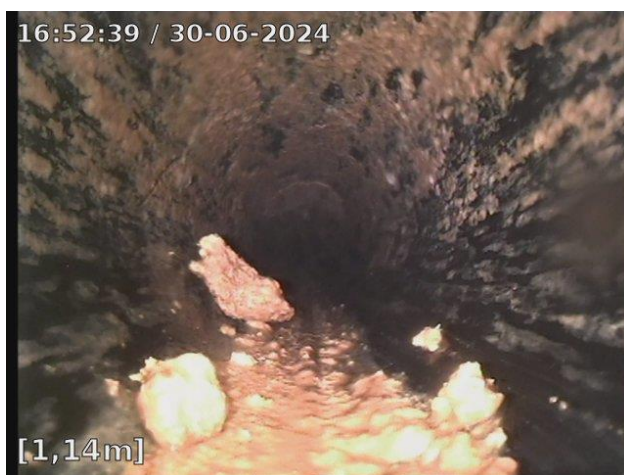
After the bend

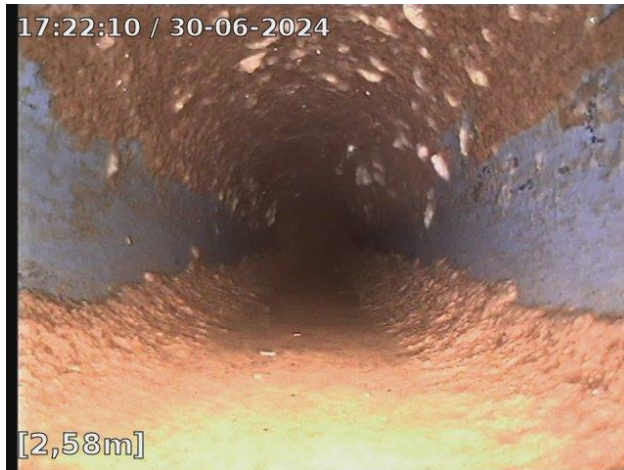
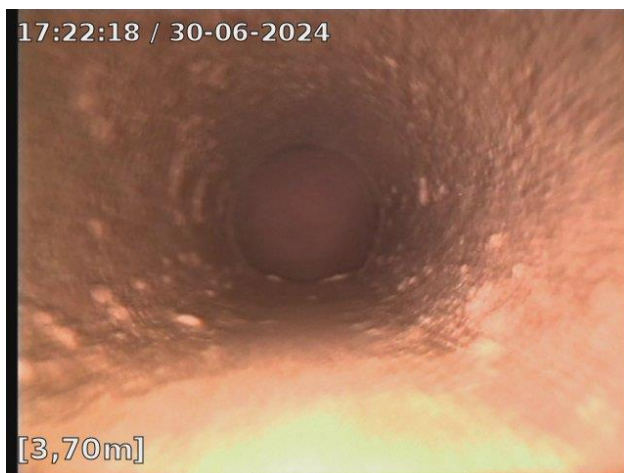
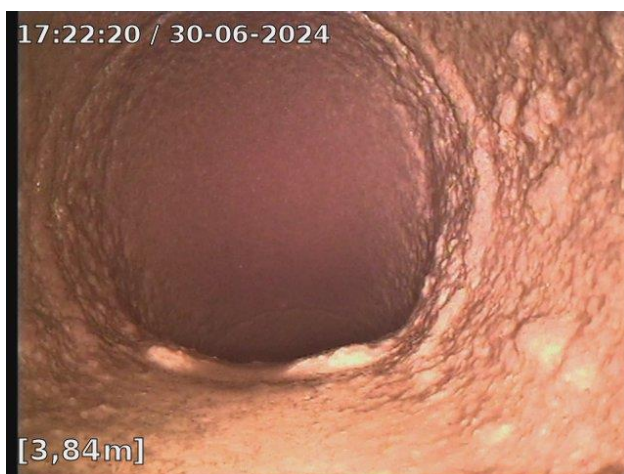
Entering a transport pocket

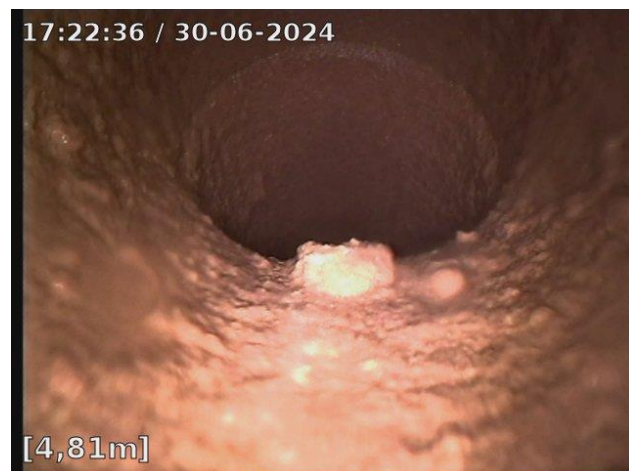
Leaving a transport pocket

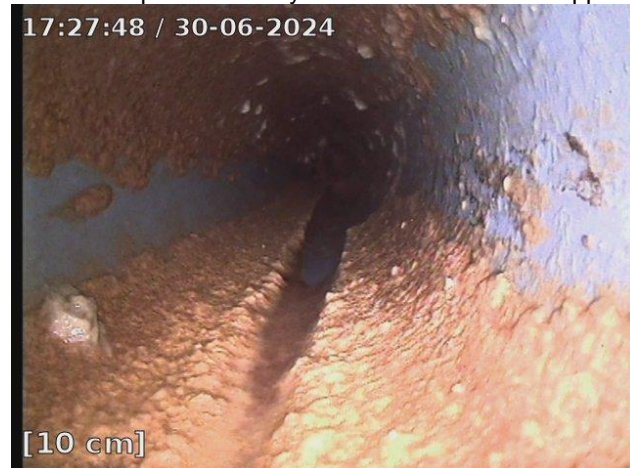
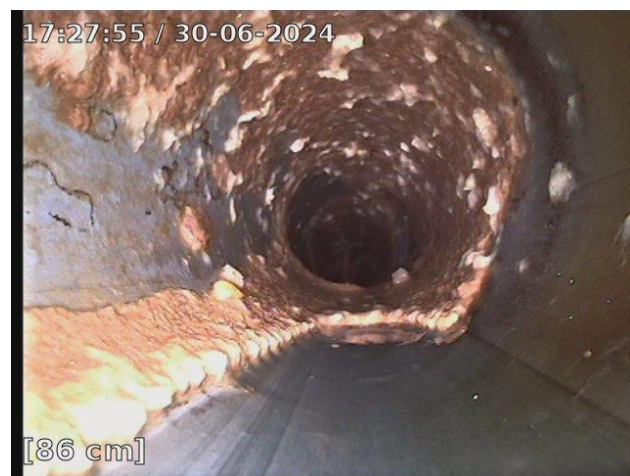
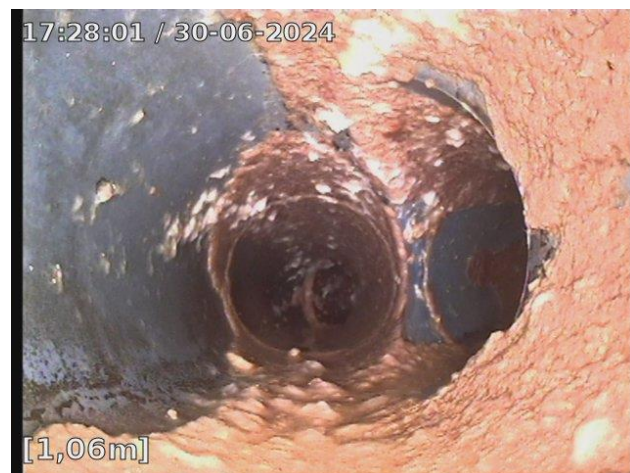
Appendix 1f Point 5b

Camera inspections away from vacuum station / opposite direction of vacuum station / point 5a

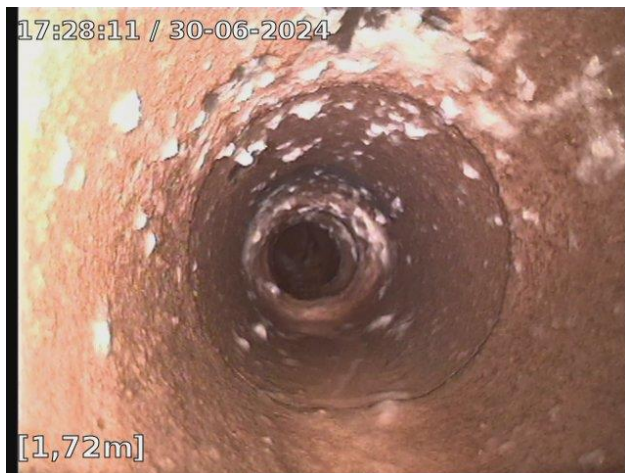
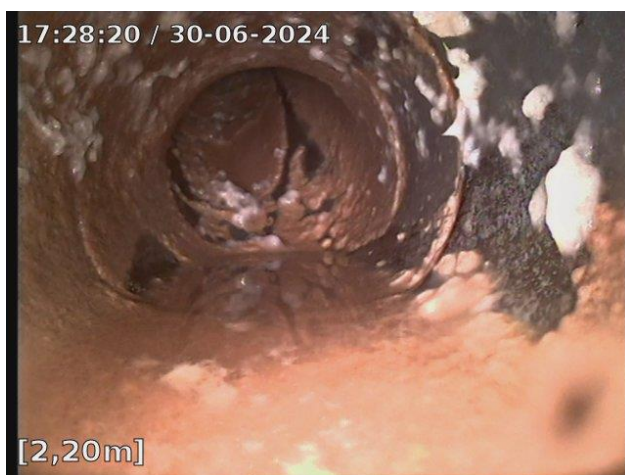
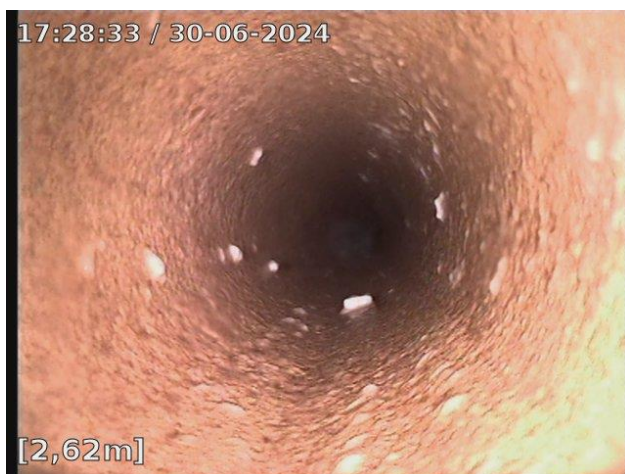
On the right the connection of another vacuum pipe is visible. The pipe wall opposite the connection is clean

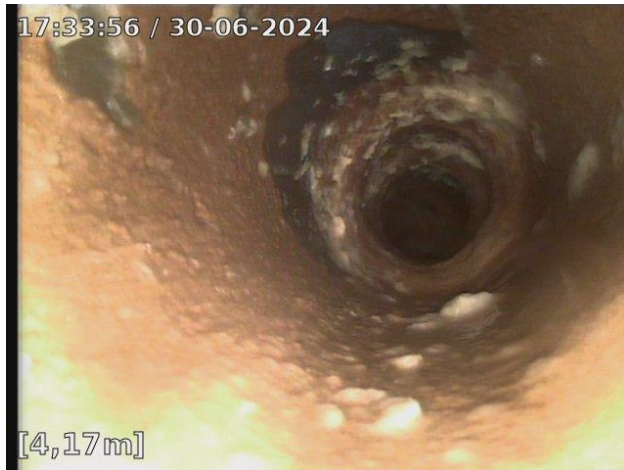
Smaller camera, the bottom of the image is the bottom of the pipe

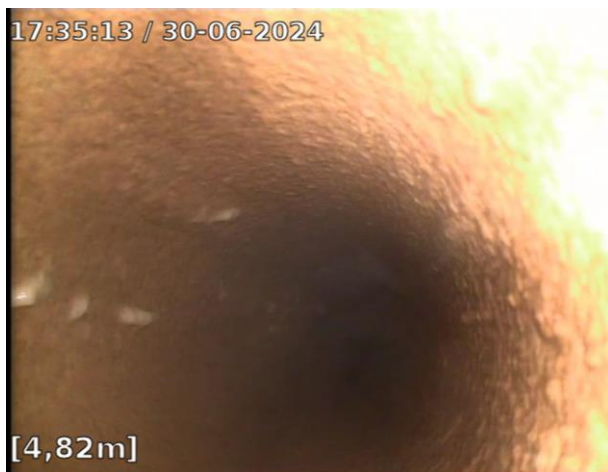
Smaller camera. Vertical pipe, moving upwards

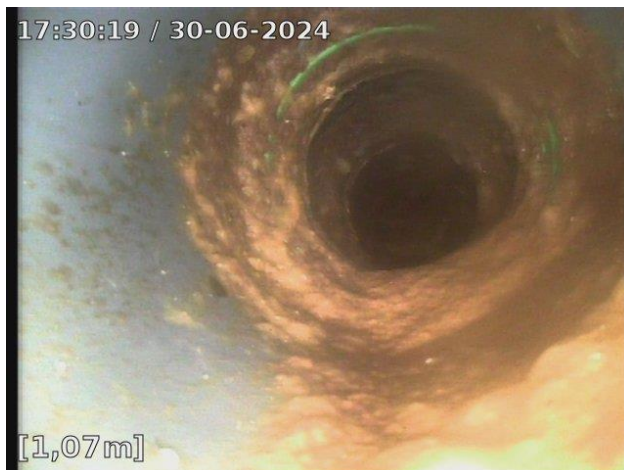
Smaller camera, into the connecting pipe which is visible in the images with the larger camera at 1,06 m (see images above).

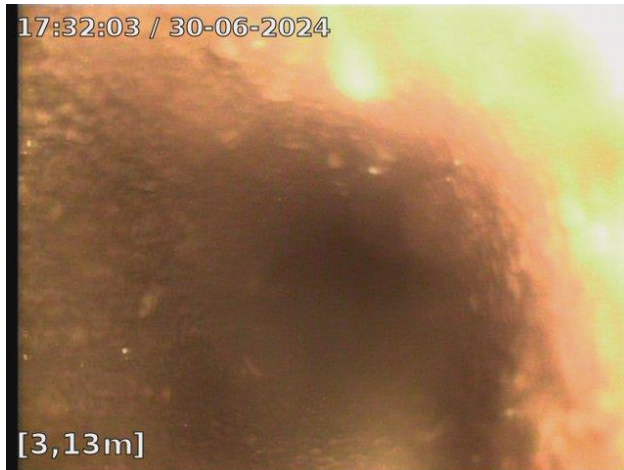
Smaller camera, top right is the bottom of the pipe

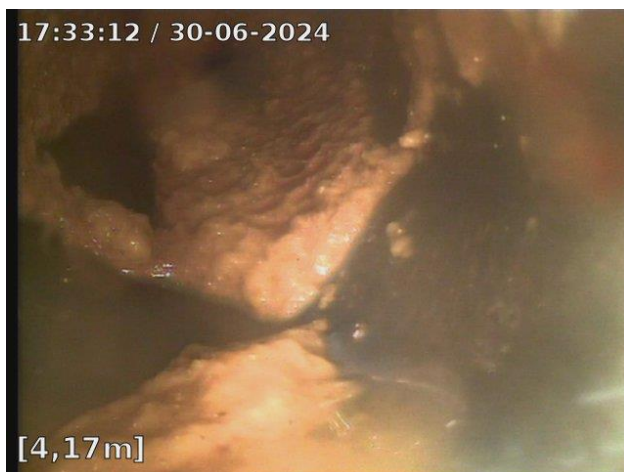
Smaller camera, bend

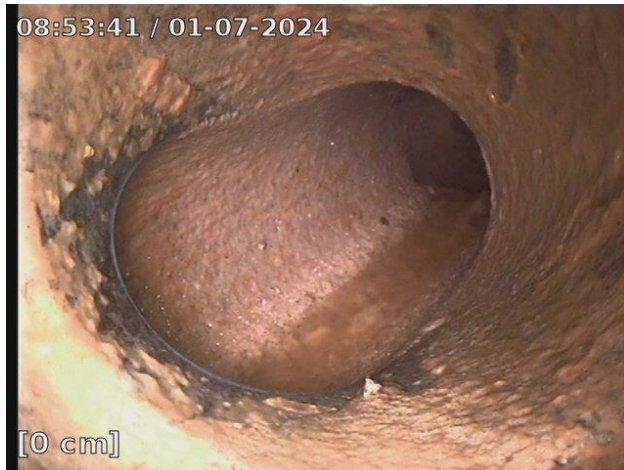
Bend

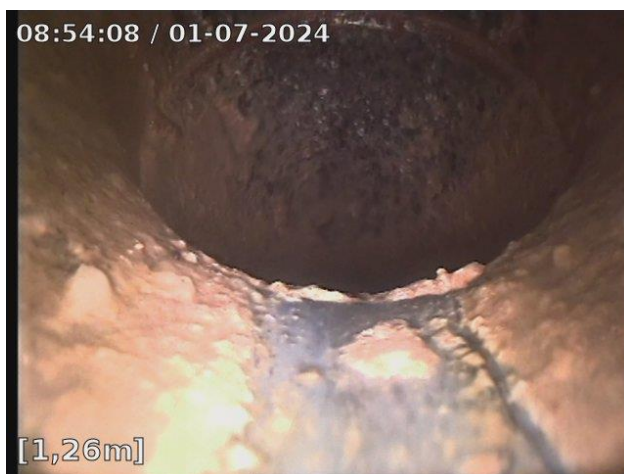
Bend

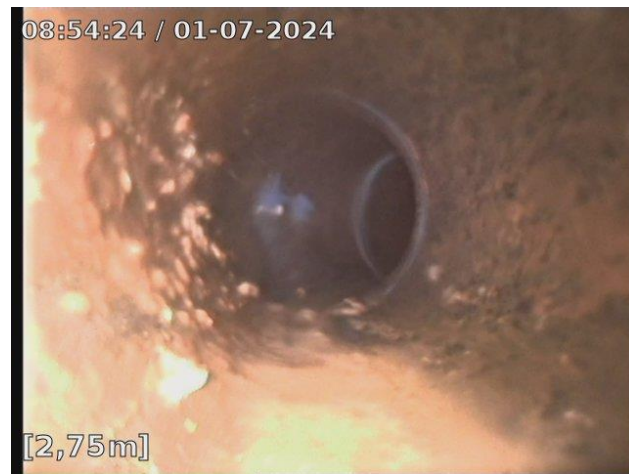
Bend

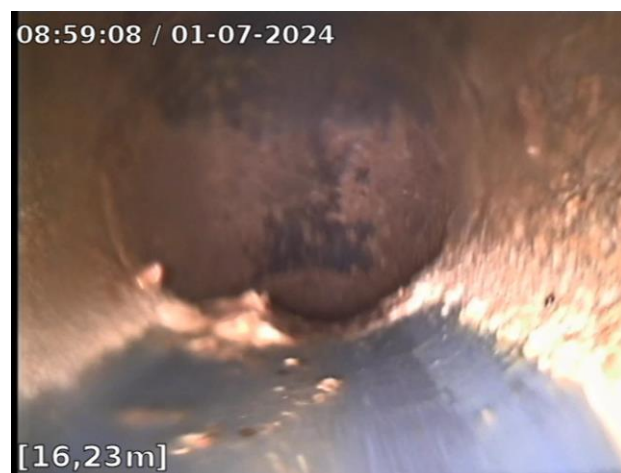
Start of transport pocket at inspection point 1

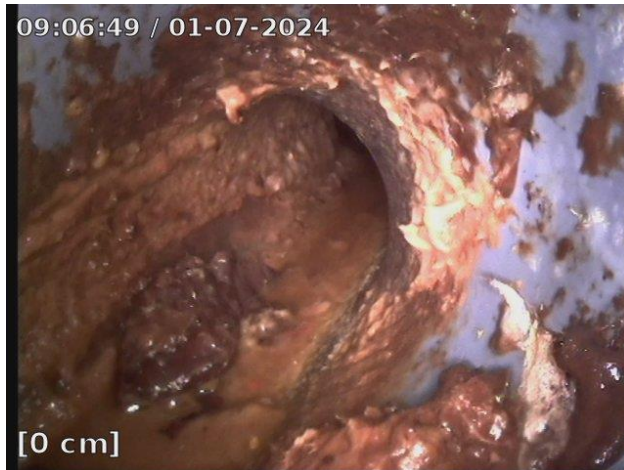
Appendix 2c Point 3

Bend

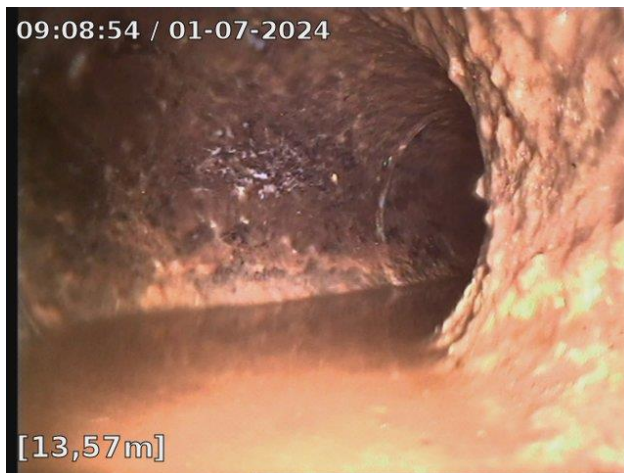
Bend

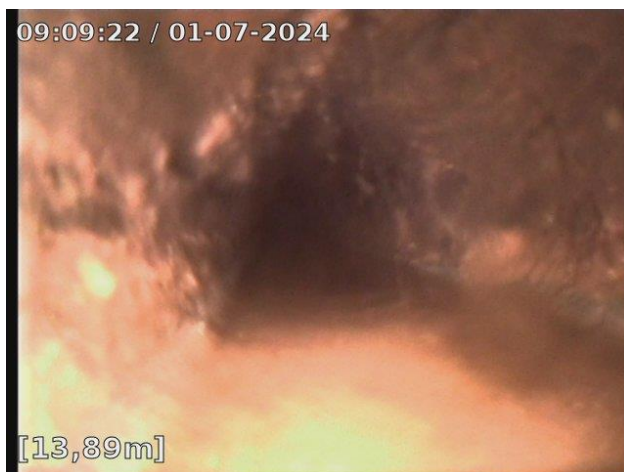
Immediately after the bend

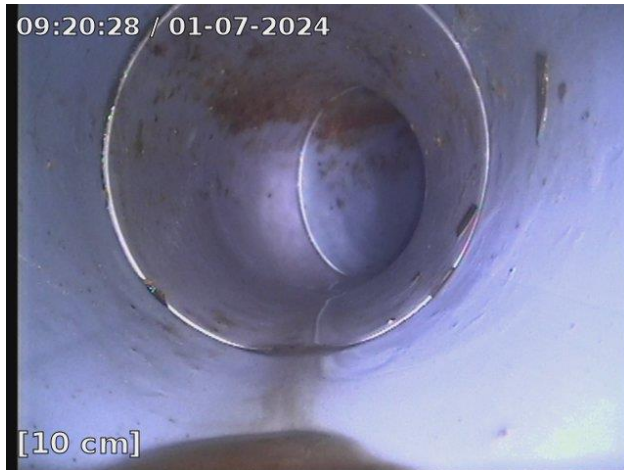
Appendix 2d Point 4

Camera inserted at the descaling gel dosing point. No vacuum sewer was connected to this point (which is why the piping is clean at the start)

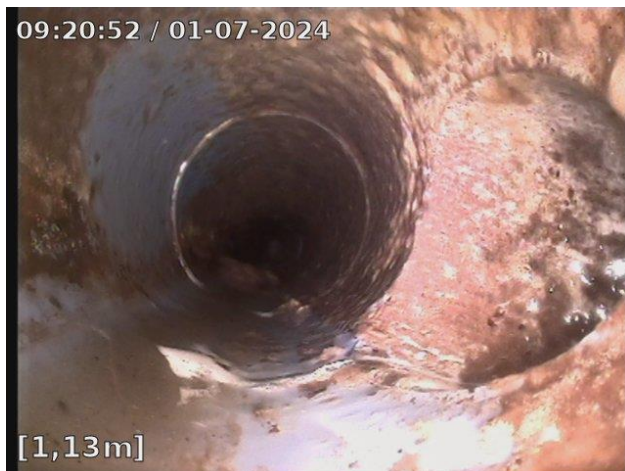
On the right the connection of the first vacuum pipe is visible you see the first vacuum pipe connected to the line. The pipe wall opposite the connection is relatively clean. The deposits in the front are probably due to splashing of the black water into the main pipe.

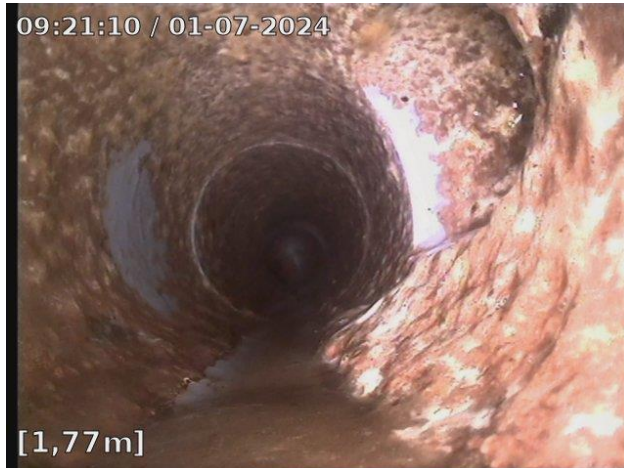
On the right the connection of another vacuum pipe is visible. The pipe wall opposite the connection is cleaner

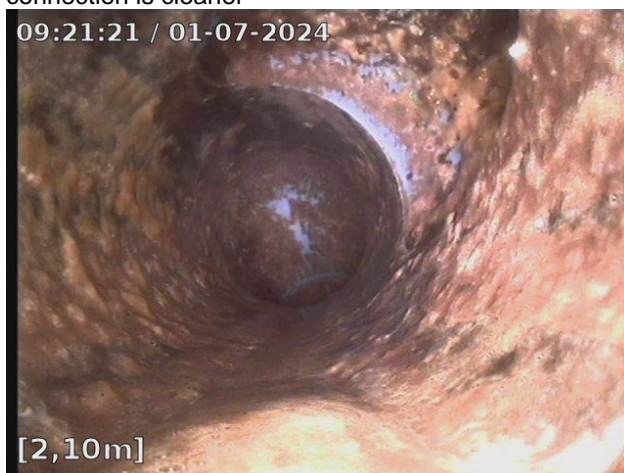
Bend start of transport pocket

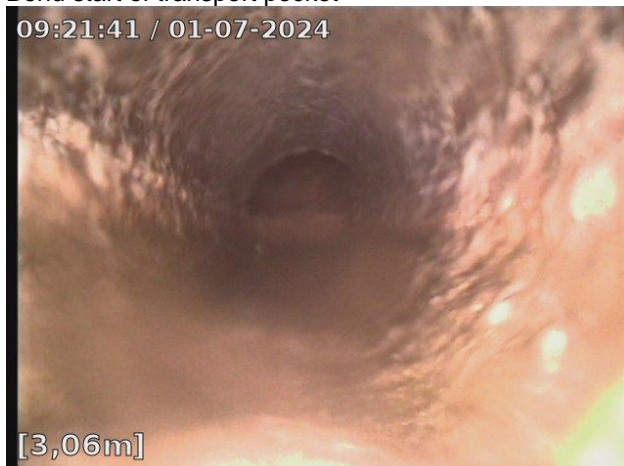
Bend end of transport pocket

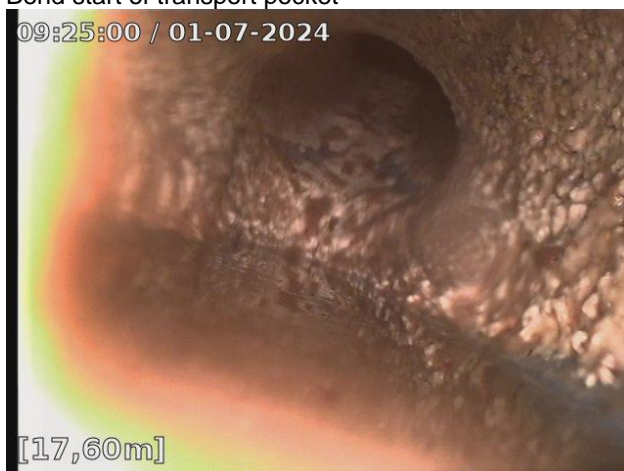
Bend end of transport pocket

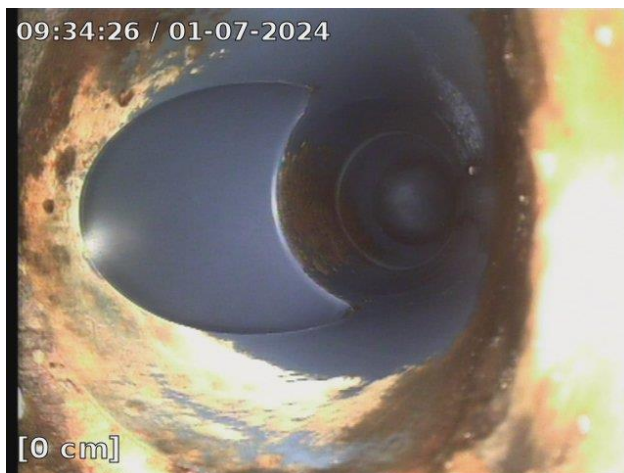
Appendix 2e Point 5

Location 5a is the inspection opening in de insulation material of the ceiling of the garage. The small camera was used. This camera does not have a self-levelling camera head to keep the image upright. In case the image is tilted, it is indicated which side is the bottom of the pipe.

The right side of the image is the bottom. The connection of the first vertical vacuum pipe on this line is visible on the left side of the image. The pipe wall opposite the connection cleaner

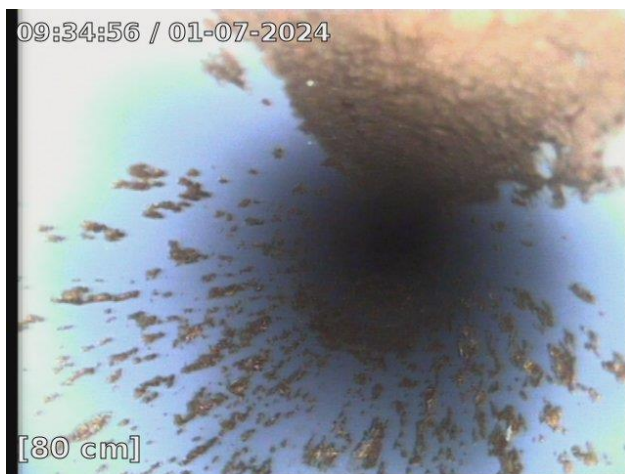
The deposits have formed at the bottom of the pipe

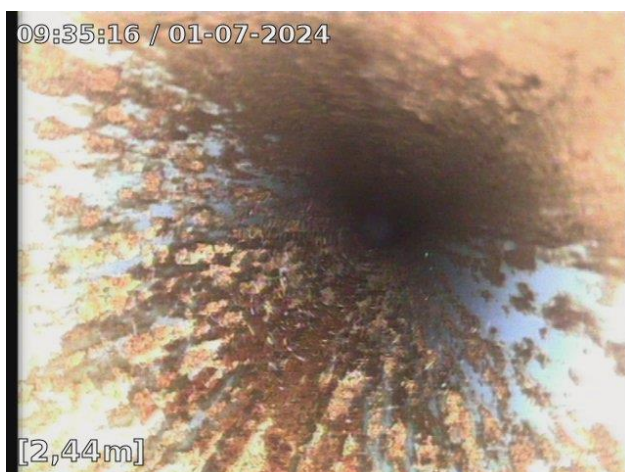
The deposits have formed at the bottom of the pipe

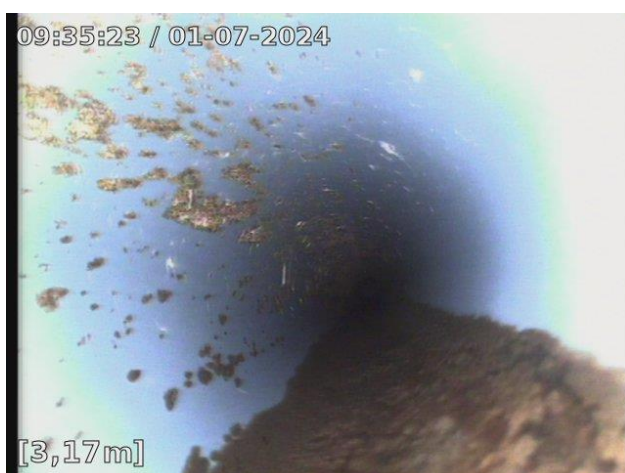
The deposits have formed at the bottom of the pipe

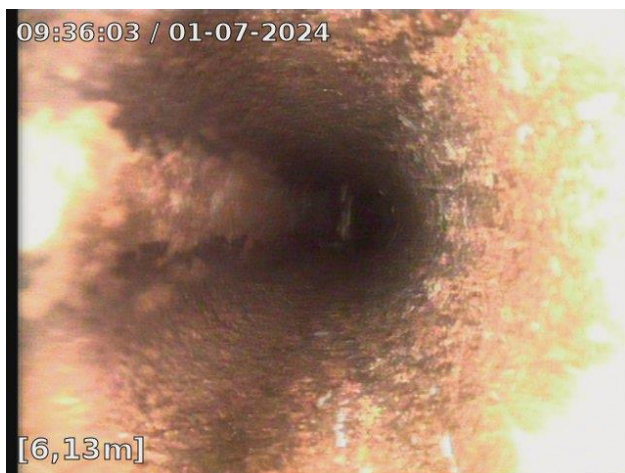
The left side of the image shows the bottom of the pipe

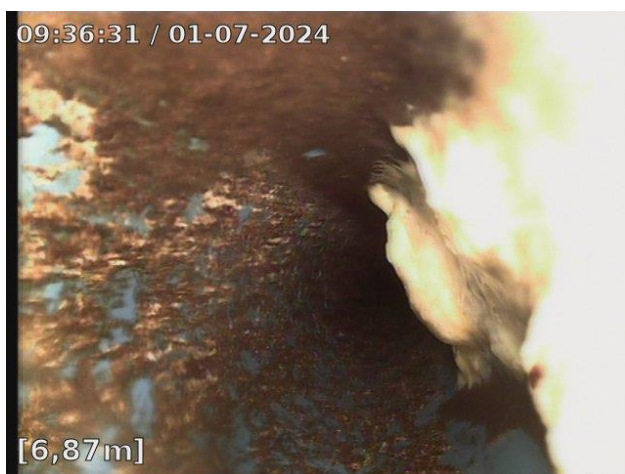
The right side of the image shows the bottom of the pipe

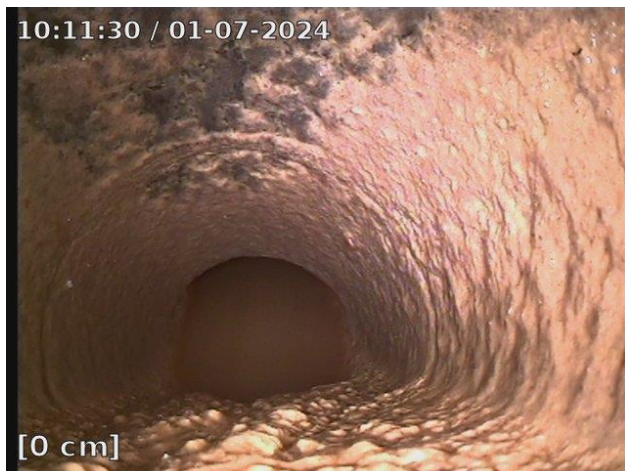
Appendix 3a Point 6

Bend into the transport pocket

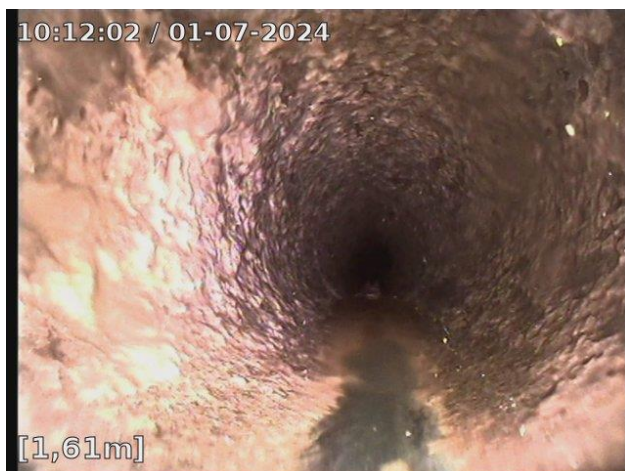
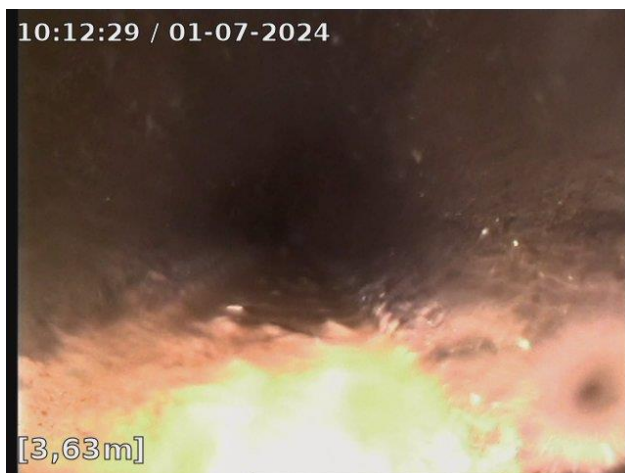
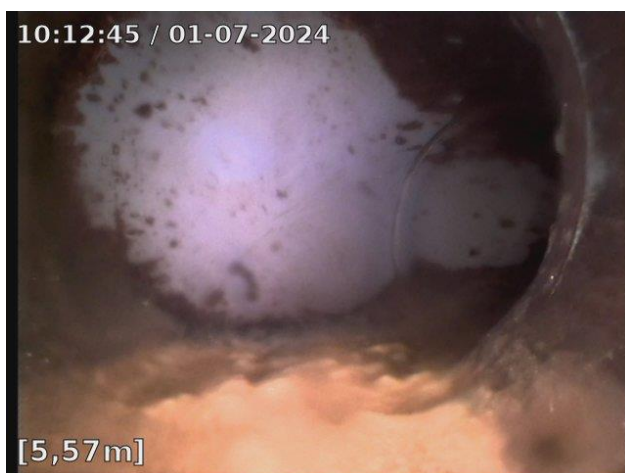
Bend

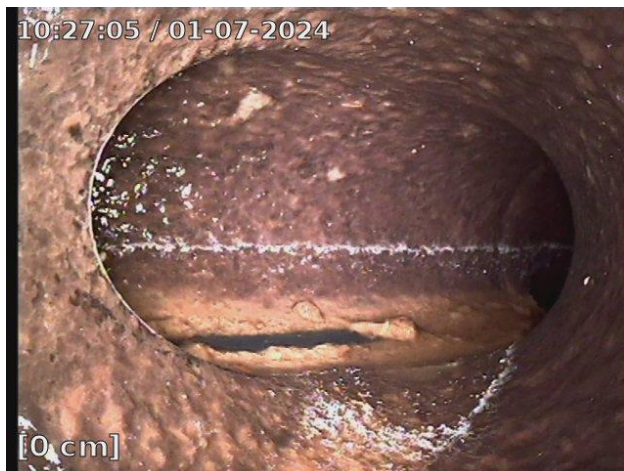
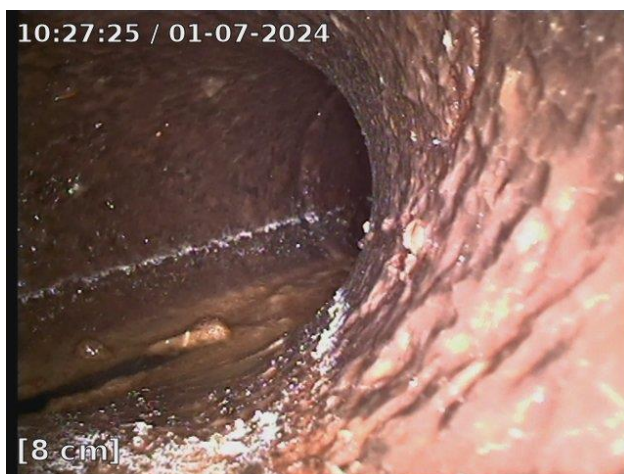
Appendix 3b Point 7

Bend

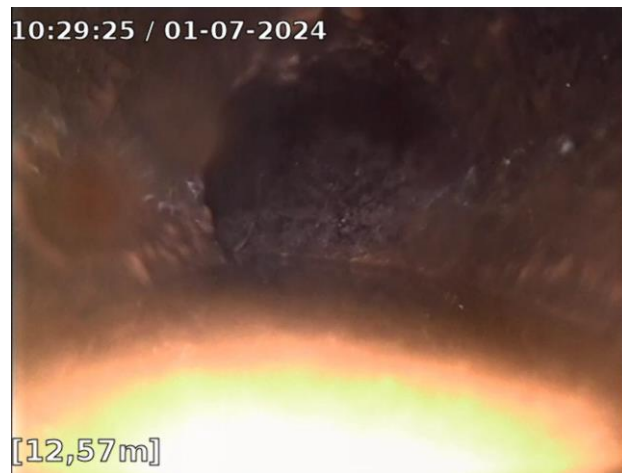
Bend towards the left

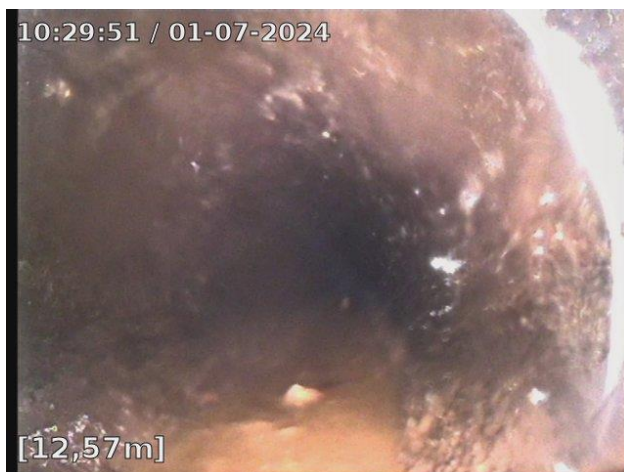
Immediately after the bend

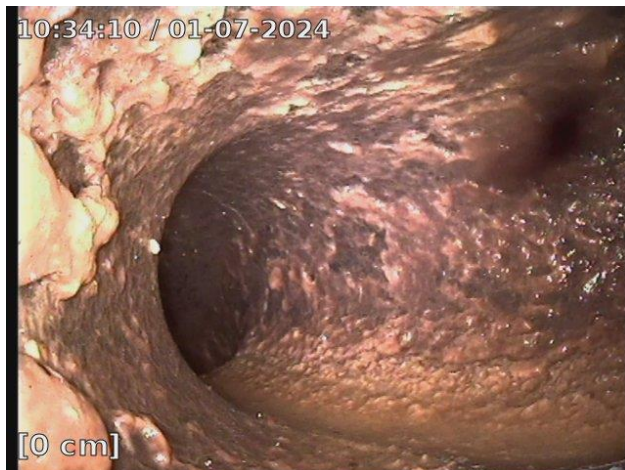
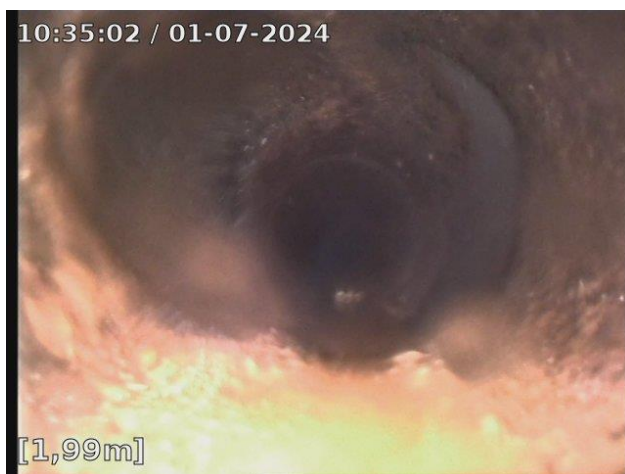
Appendix 3c Point 8

In November 2023, this pipe segment was cleaned using high-pressure flushing.

On the left, the connection of another vacuum pipe is visible. The pipe wall opposite the connection is clean

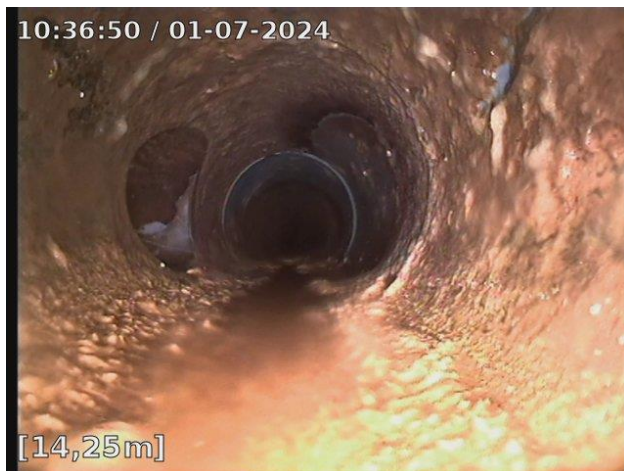
On the left, the connection of another vacuum pipe is visible. The pipe wall opposite the connection is cleaner.

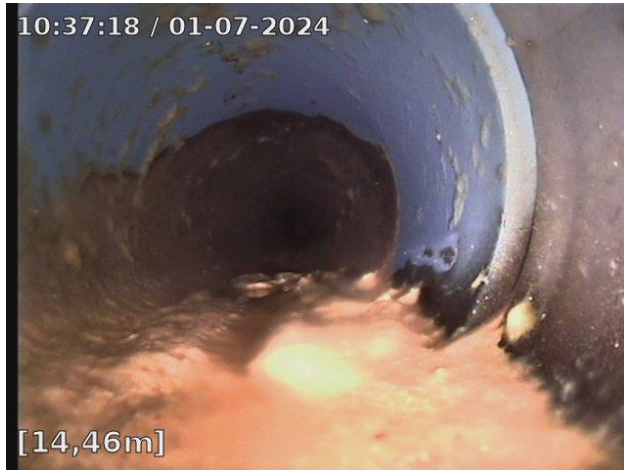
Here, the transition to a short pipe segment of another type of material is visible. Unknown why this segment is of another material type. Deposits seem to attach less well to this material, since the piping is very clean compared to the segments before and after.

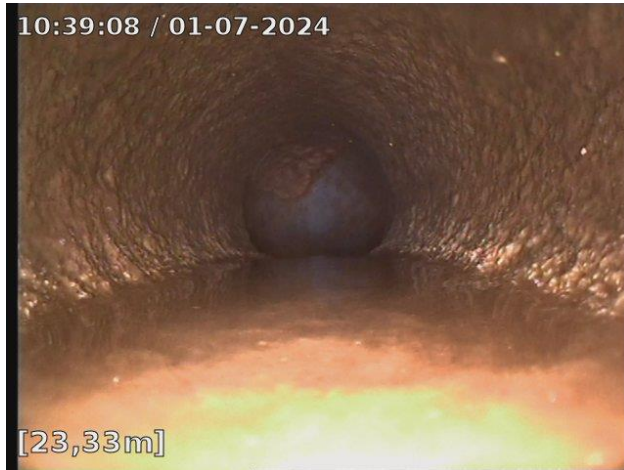
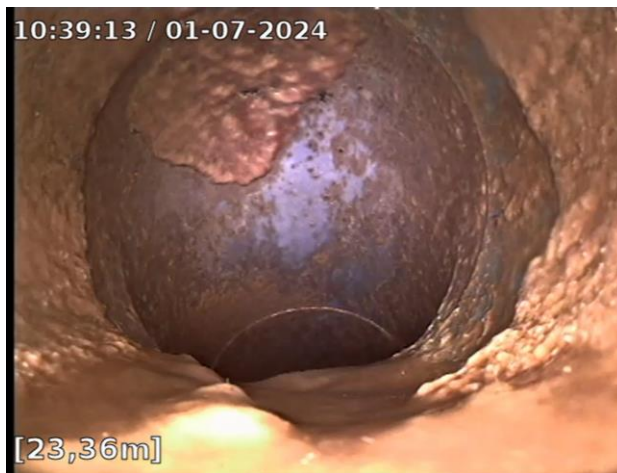
Bend into transport pocket

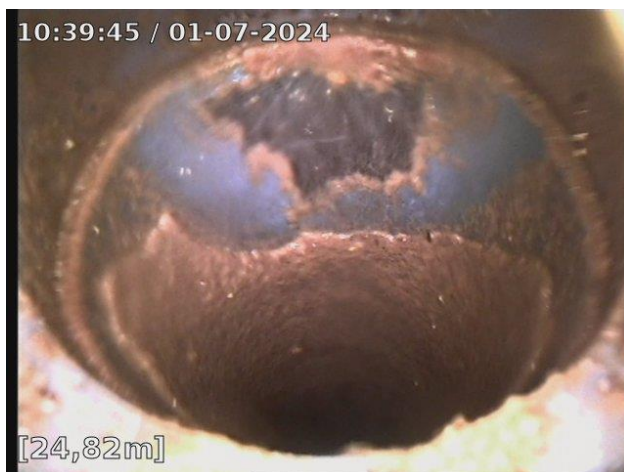
Bend out of transport pocket

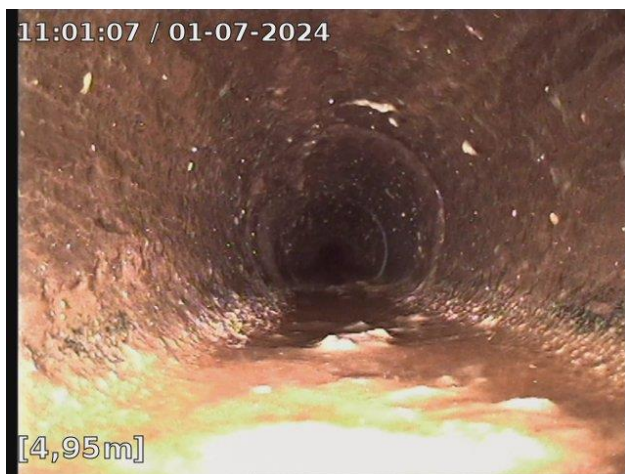
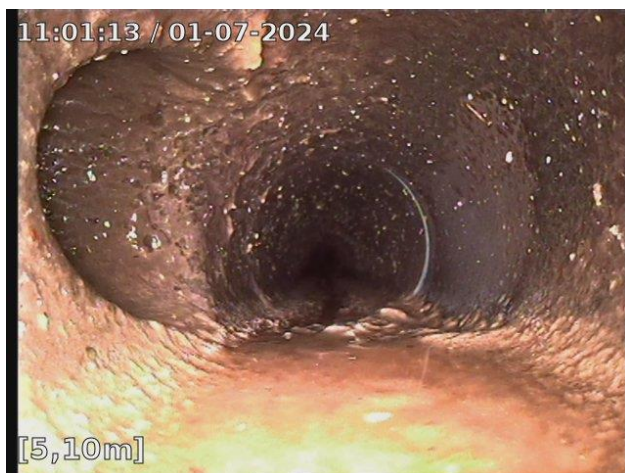
In this piping segment, the transport pocket has been replaced due to blockages.

On the left, the connection of another vacuum pipe is visible. The pipe wall opposite the connection is cleaner

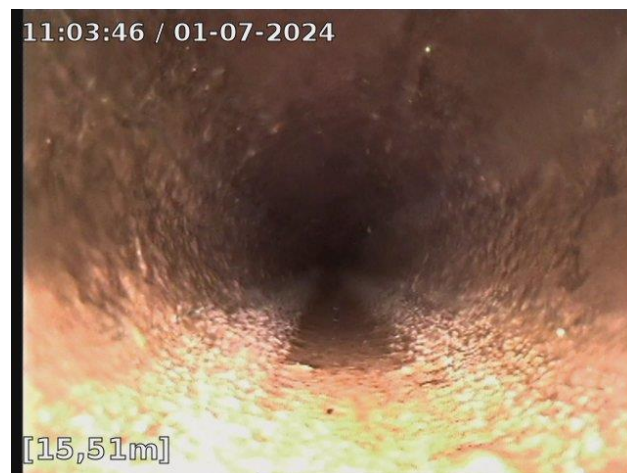
On the left, the connection of another vacuum pipe is visible. The pipe wall opposite the connection is clean

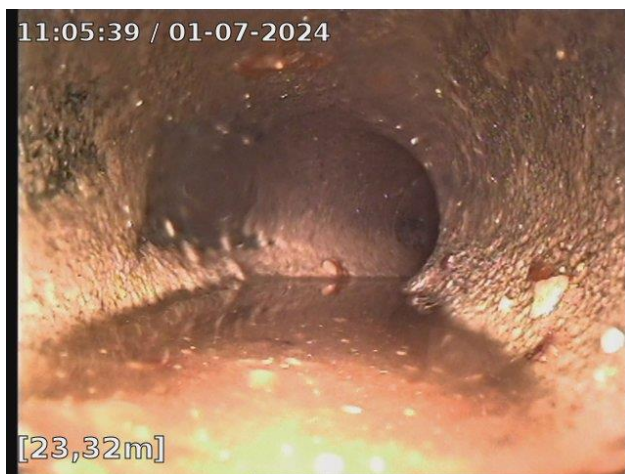
Bend

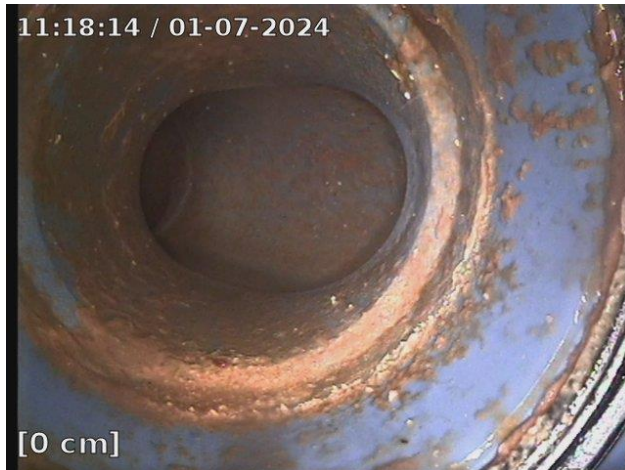
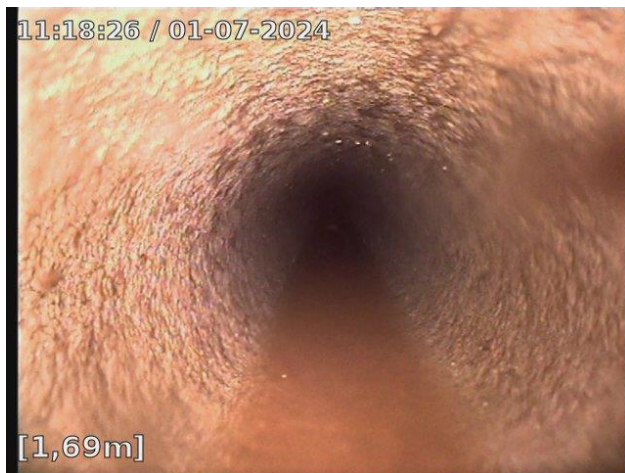
Appendix 3e Point 10

Inspection point in the technical room

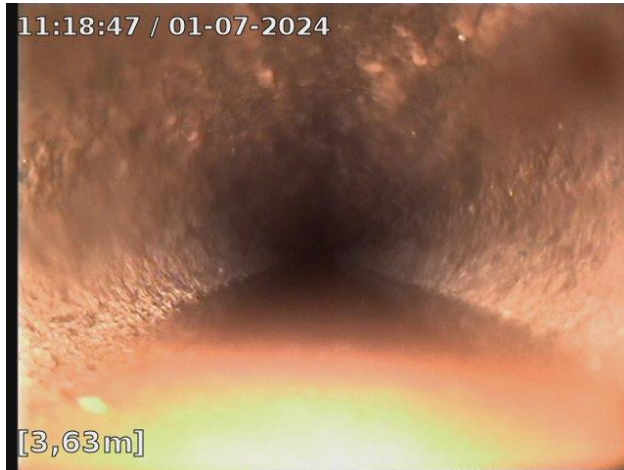
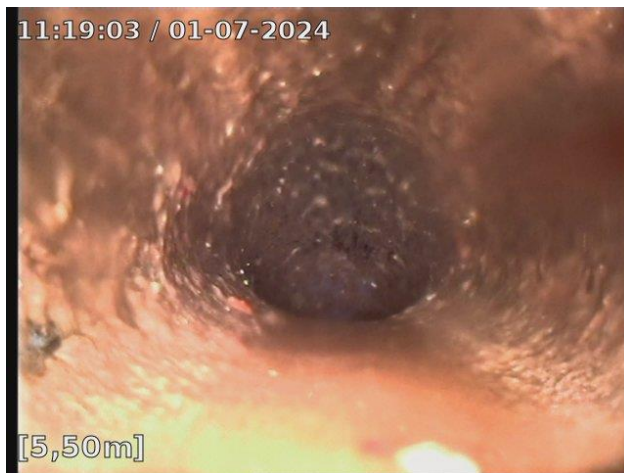
Downwards bend

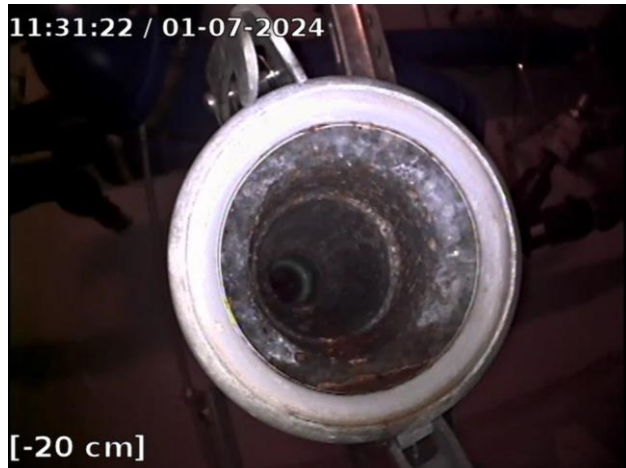
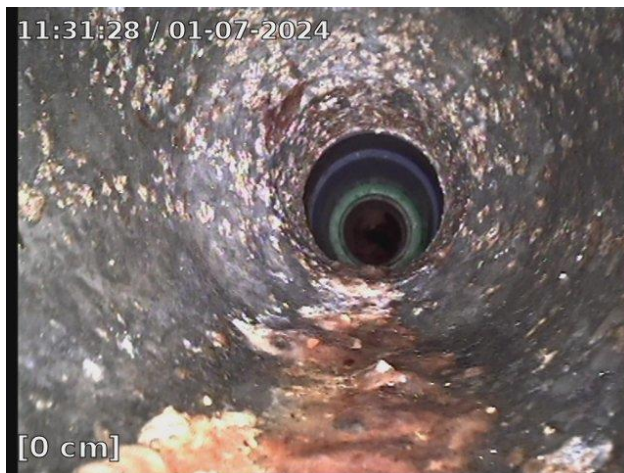
Appendix 3f Point 11

The camera was inserted through the Perrot coupling, as shown in the following image.

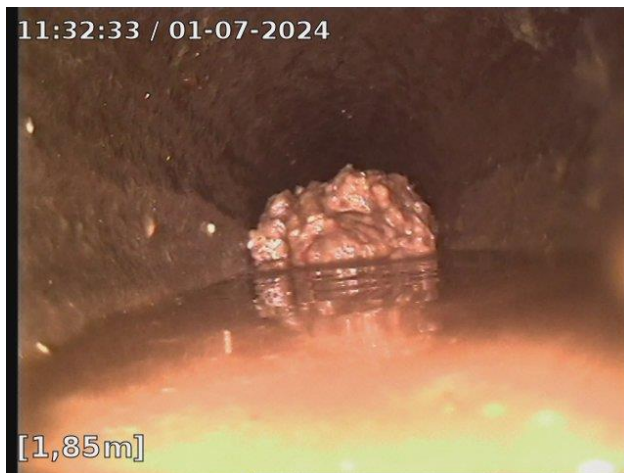
Toilet paper is visible

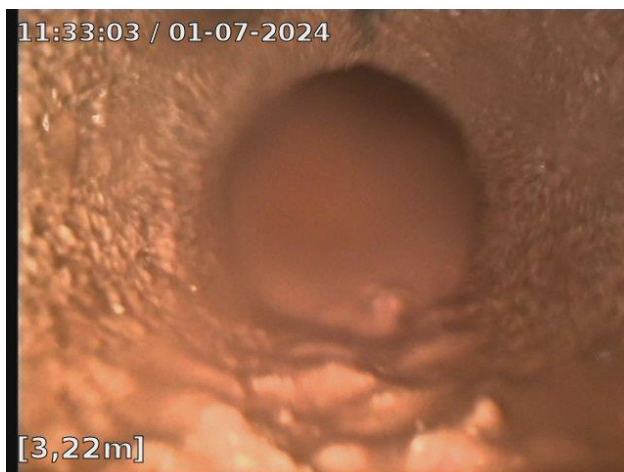
Shut-off valve in the public area

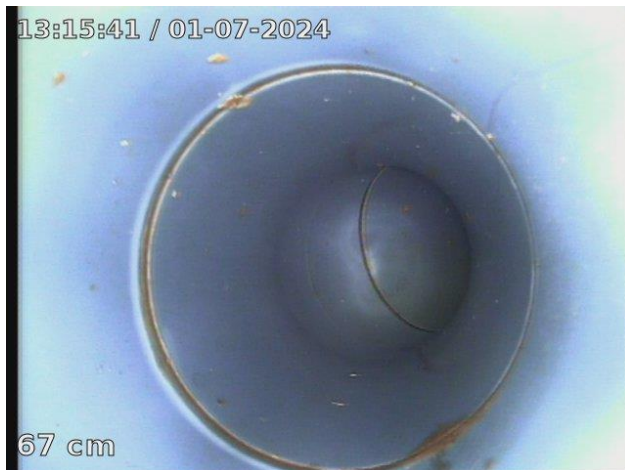
Appendix 4a Point 12

The small camera was inserted at a toilet on the 4th floor into the vertical pipe.

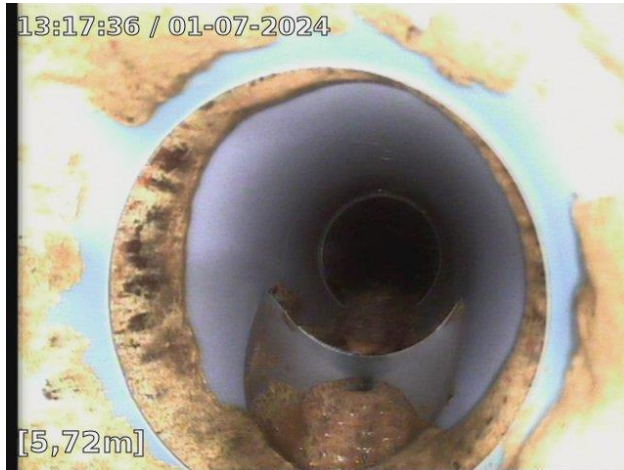
Connection of another vacuum pipe. The pipe wall opposite the connection is clean

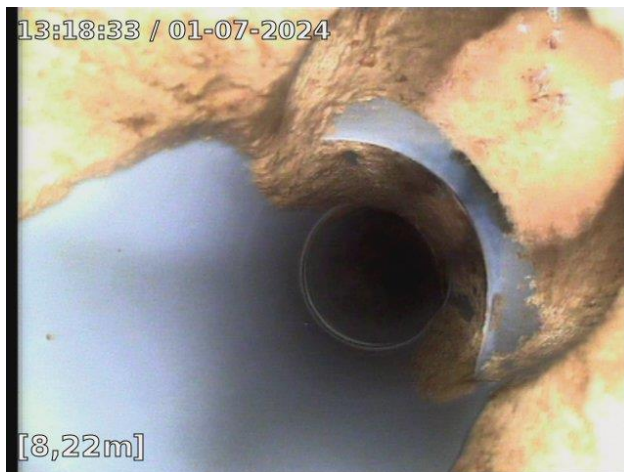
On the right, the connection of another vacuum pipe is visible. The pipe wall opposite the connection is clean

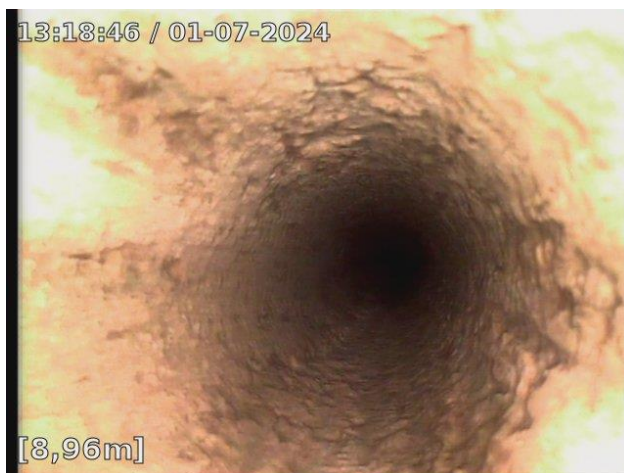
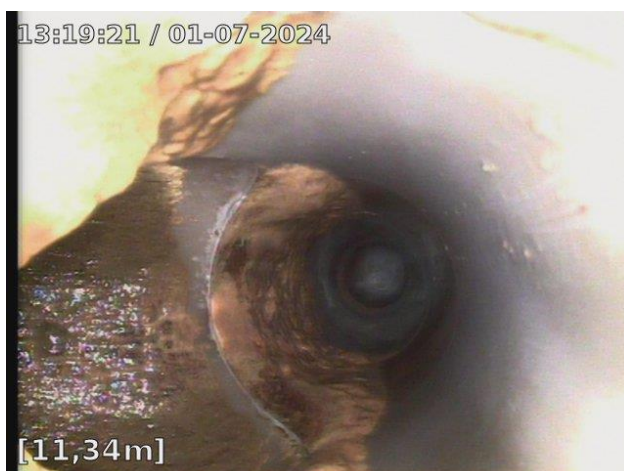
On the left, the connection of another vacuum pipe is visible. The pipe wall opposite the connection is clean
