Execution of camera inspections at vacuum sewerage at 4 project sites

Oceanhamnen - Helsingborg

November 29, 2024

Our reference R002-1288399-002RFL-V01-mdg-NL

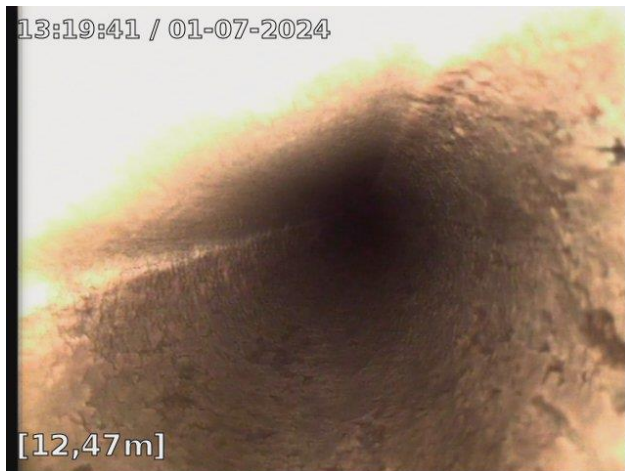
Horizontal pipe. The upper left side is the bottom of the pipe.

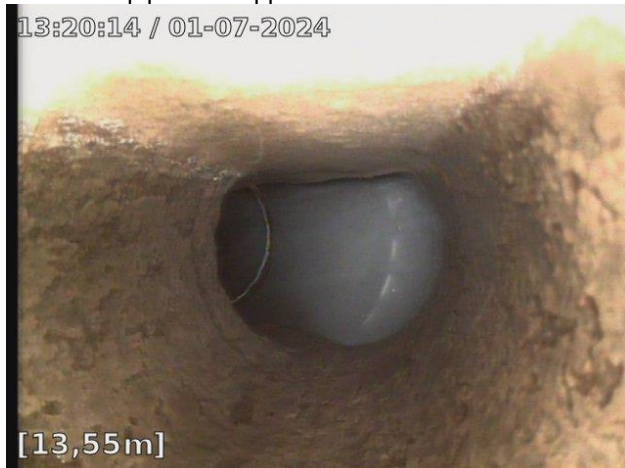
Horizontal pipe, bend. The top of the image is the bottom of the pipe.

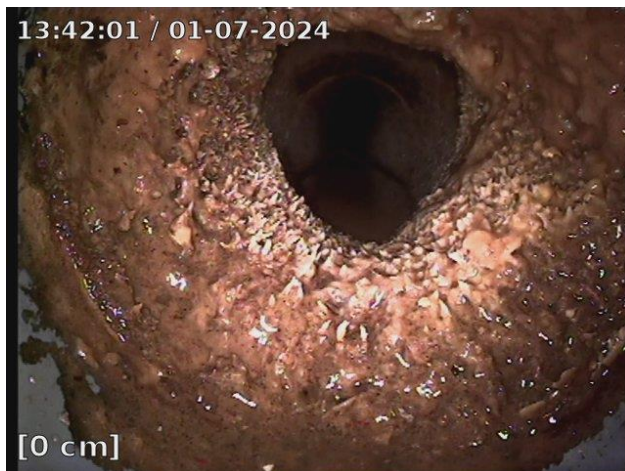
Appendix 4b Point 13

Crystals are clearly visible.

Based on the findings, it is recommended to clean the indoor pipes to prevent further scaling formation and reduce the risk of blockages. It is important to take into account the type of scaling: soft viscous deposits or hard crystalized deposits. The camera inspections together with some pipe sections that were dismantled have shown that the majority of the deposits are hard and crystallized, for which physical or chemical cleaning methods such as high-pressure flushing or strong acid recirculation are likely most effective. Because the scaling seems to be hard and crystallized, it is expected that flushing the pipes with foam balls, as is applied in Hamburg as preventive measure, will not be effective. This also accounts for flushing with crushed ice, little to no effect is expected because of the hard scaling present. In addition, it is recommended to monitor the current descale dosing to quantify the actual dose and frequency.

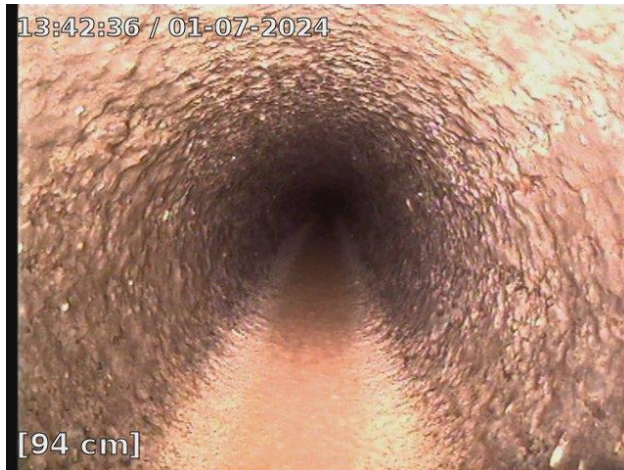
Upward bend out of transport pocket.

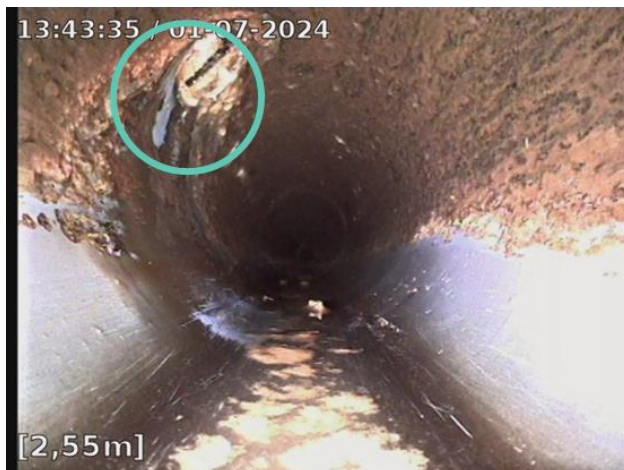
This image is taken just before the dosing point of the descaling gel. The suddenly clean bottom of the pipe is probably caused by the descaling gel.

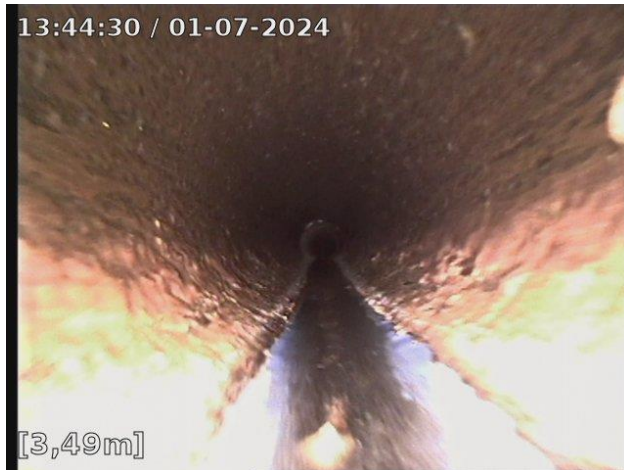
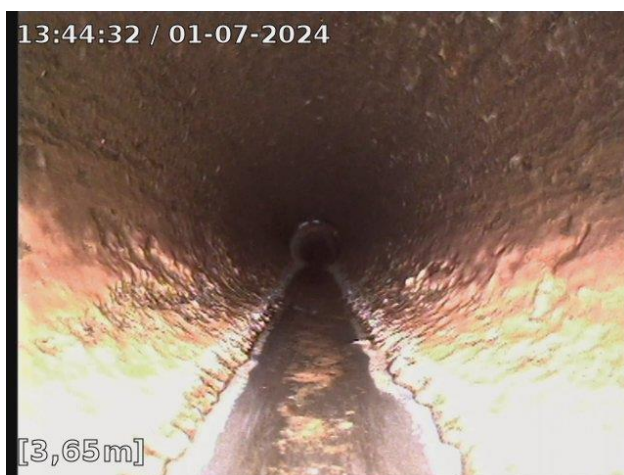
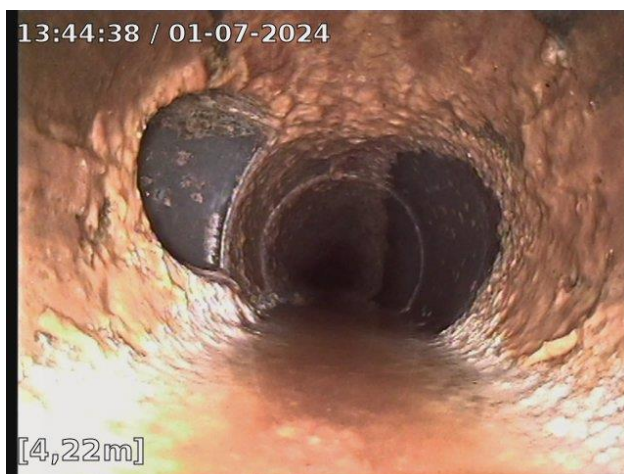
The dosing point of the descaling gel is indicated with the blue circle (10 ml every 8 hours). The effect can be seen at the bottom of the pipe

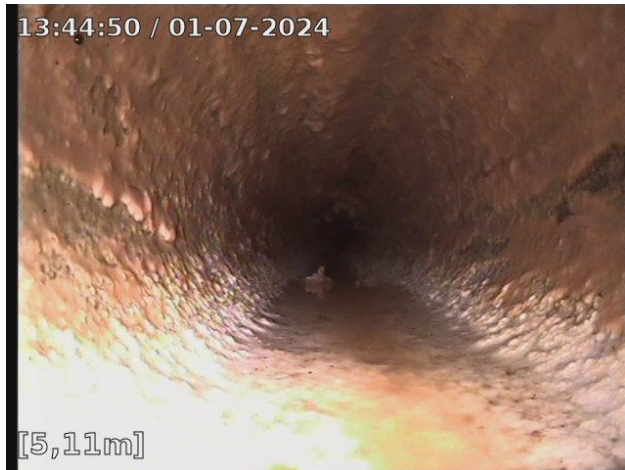
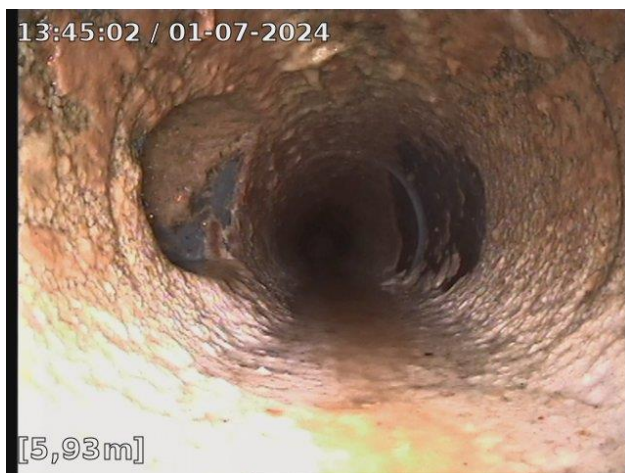
On the left, the connection of another vacuum pipe is visible. The pipe wall opposite the connection is clean

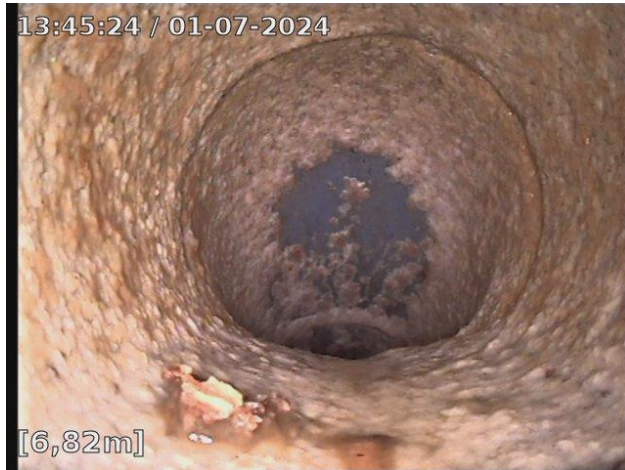
Bend into transport pocket

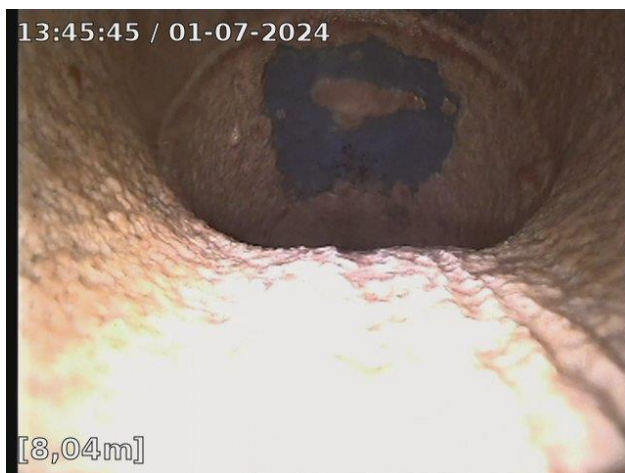
Bend out of transport pocket

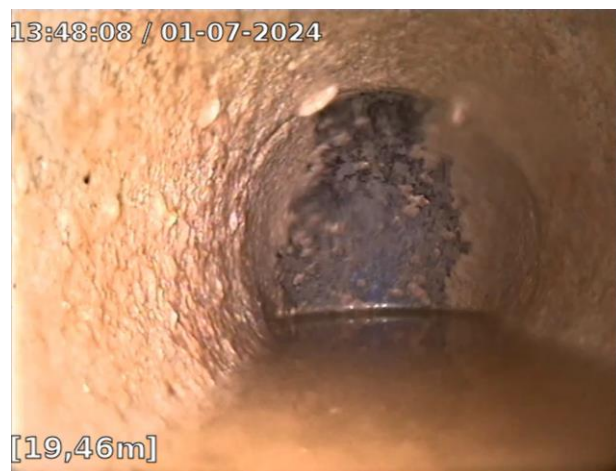
Shut-off valve

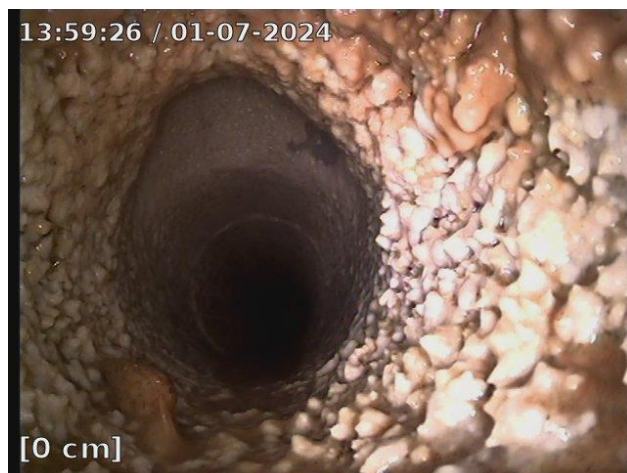
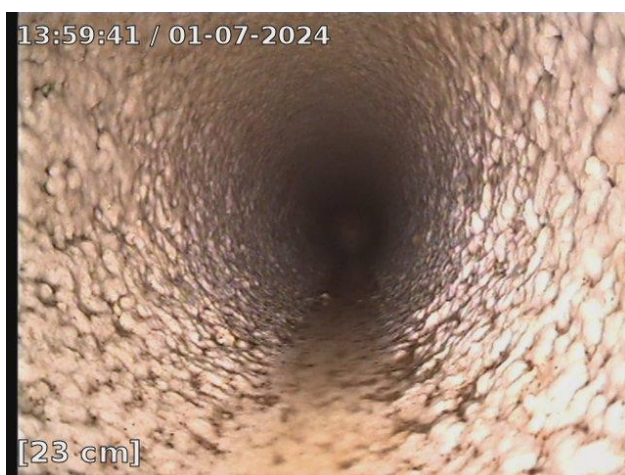
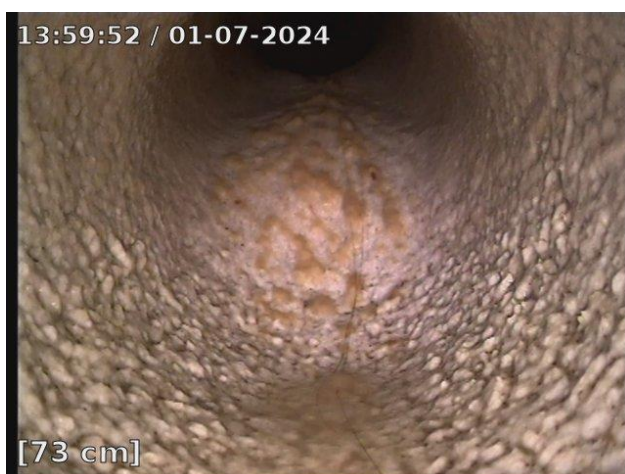
Appendix 4c Point 14

This shows a bump of deposits in the pipe in a bend, significantly narrowing the pipe diameter

After cleaning the pipes, it is recommended to periodically clean the pipes as a preventive measure. Possible preventive measures foreseen are: 1) high-pressure flushing, 2) flushing with foam balls, and 3) dosing acid with a higher dosage than currently applied. With these preventive measures, the formation of hard crystalized deposits is prevented or impaired.

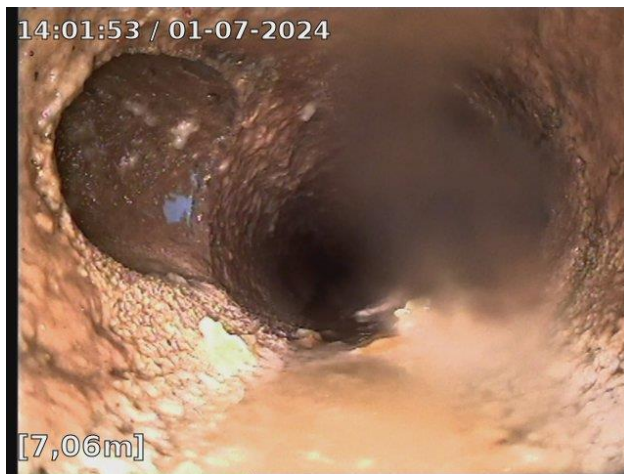
On the left, the connection of another vacuum pipe is visible. The pipe wall opposite the connection is clean

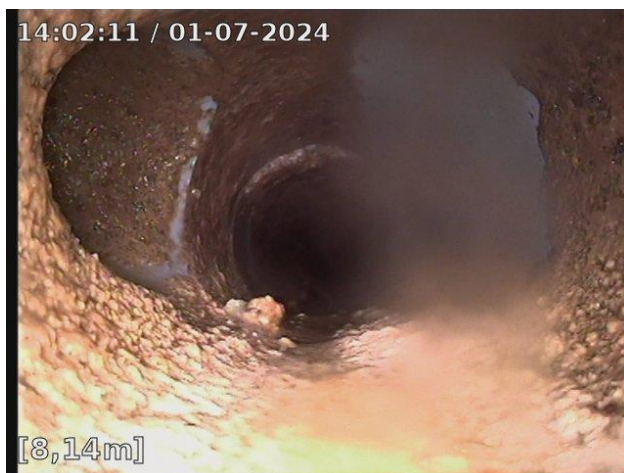
On the left, the connection of another vacuum pipe is visible. The pipe wall opposite the connection is clean

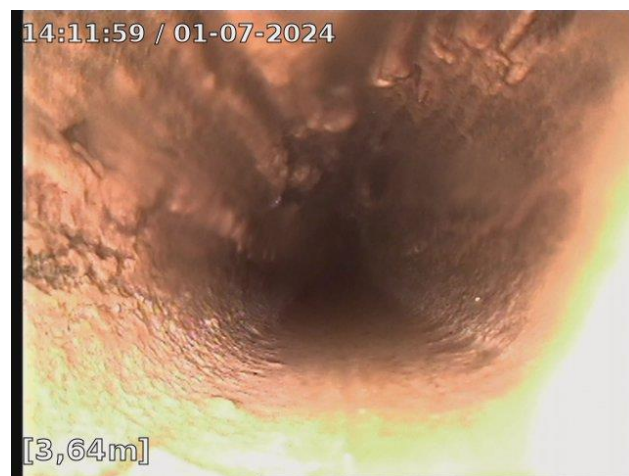
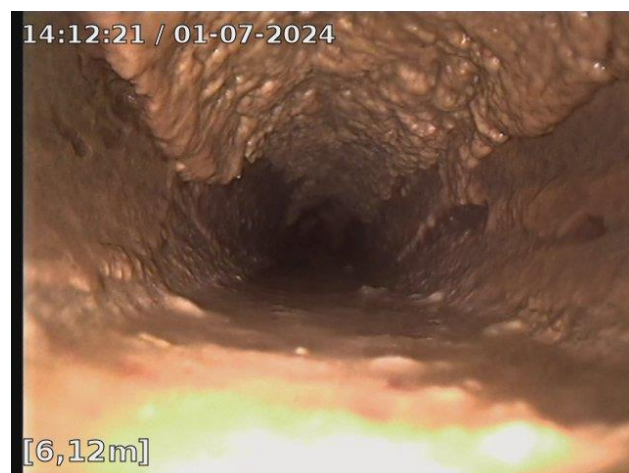
Thick layer of deposits

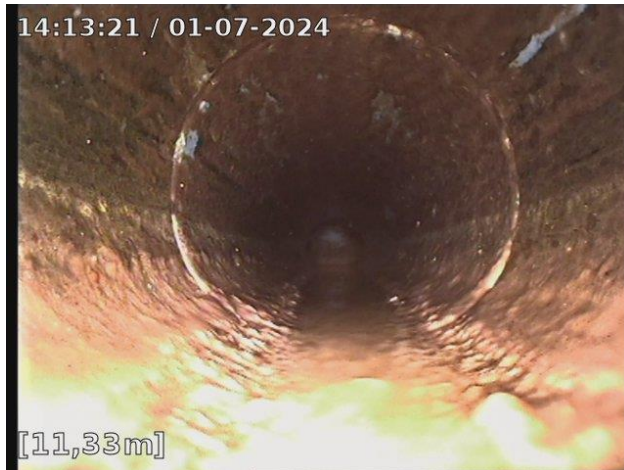
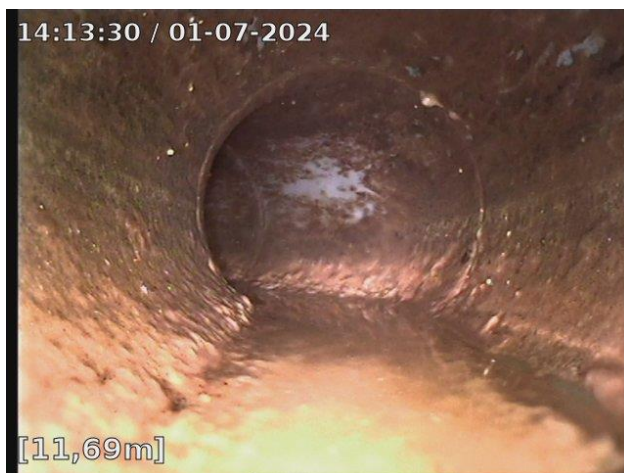
Thick layer of scaling on the top of the pipe

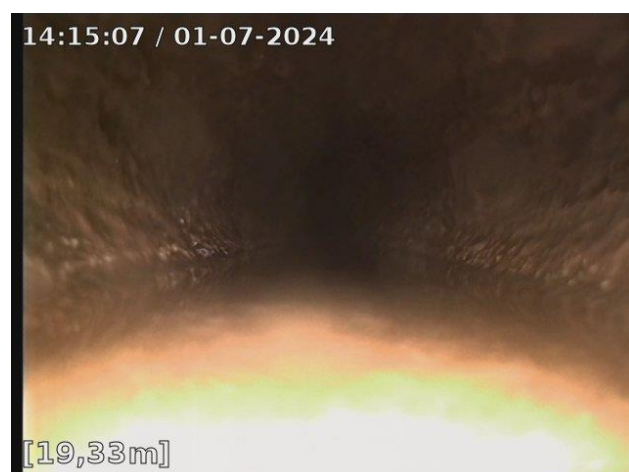
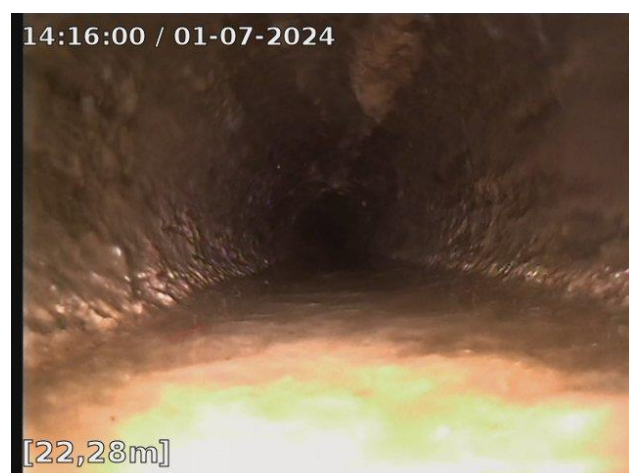
'highway effect'

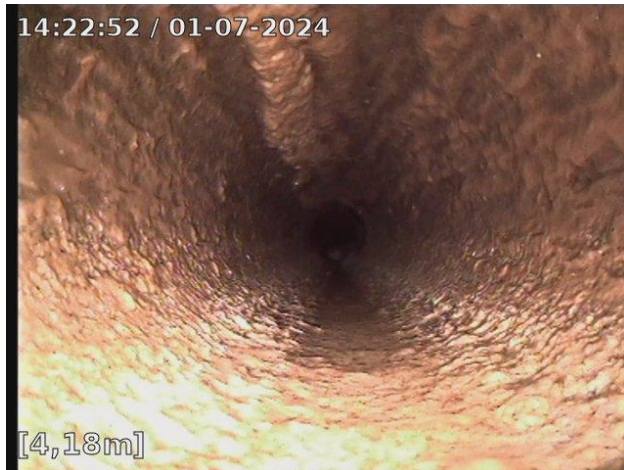
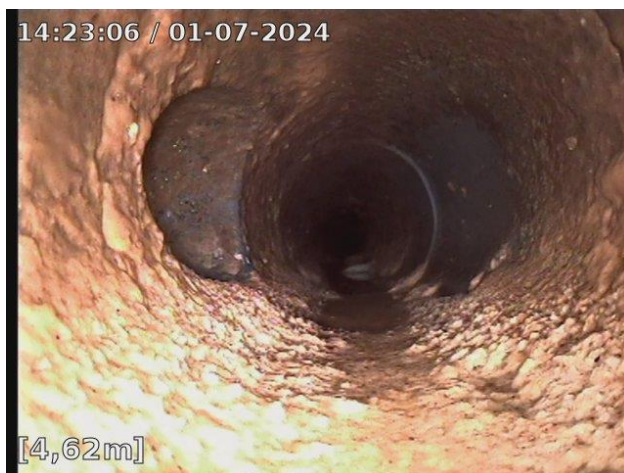
On the left, the connection of another vacuum pipe is visible. The pipe wall opposite the connection is a bit cleaner

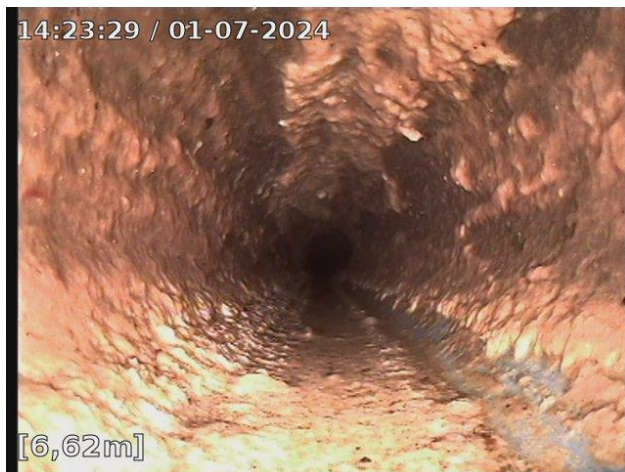
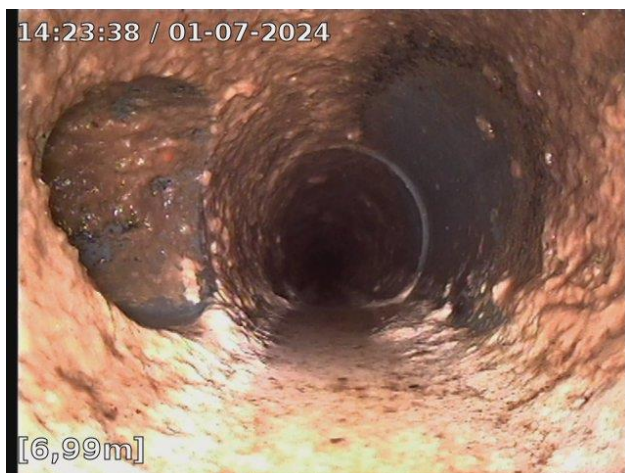
On the left, the connection of another vacuum pipe is visible. The pipe wall opposite the connection is clean

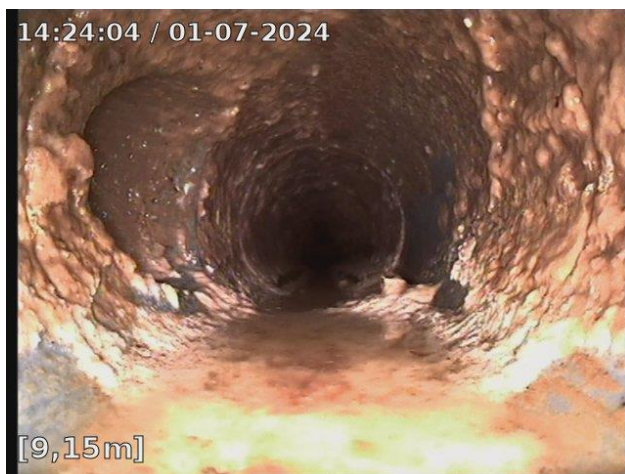
On the left, the connection of another vacuum pipe is visible. The pipe wall opposite the connection is a bit cleaner.
